TREE SURVEY MEMORANDUM

MILL POINT SOLAR I PROJECT

TOWN OF GLEN
MONTGOMERY COUNTY, NEW YORK

DECEMBER 2024

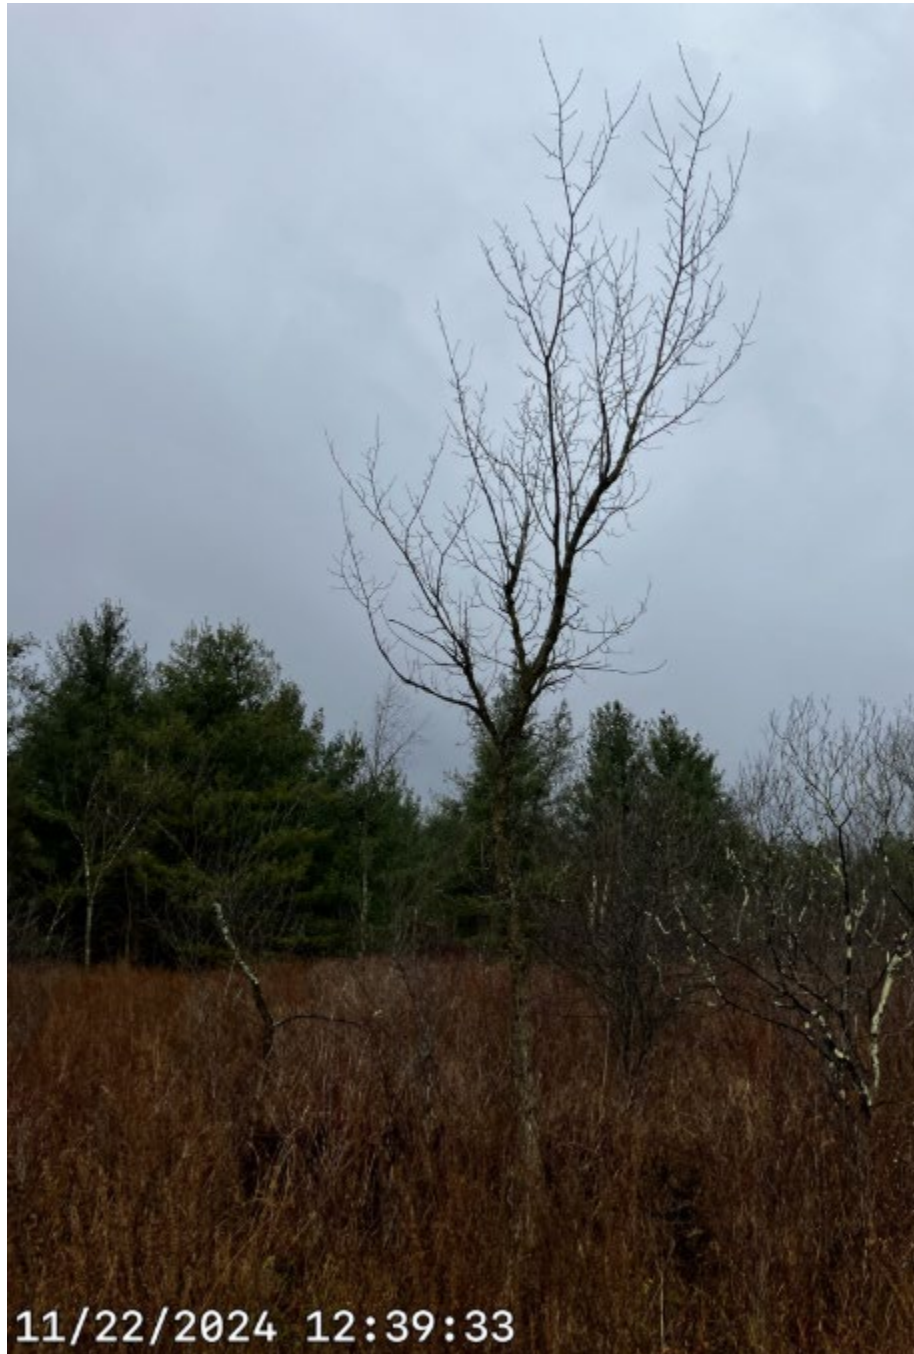
Photograph 1: Tree ID 1

American elm (*Ulmus americana*)

Species Filter: Growth Habit	Tree
Select Tree	Ulmus americana, American elm, Tree
Species	Ulmus americana
Common Name	American elm
DBH (inches)	4.2
Crown Position	Dominant
Condition	Poor
Health	Poor
Risk	Low
Notes	Tree is approximately 15' tall
Photos

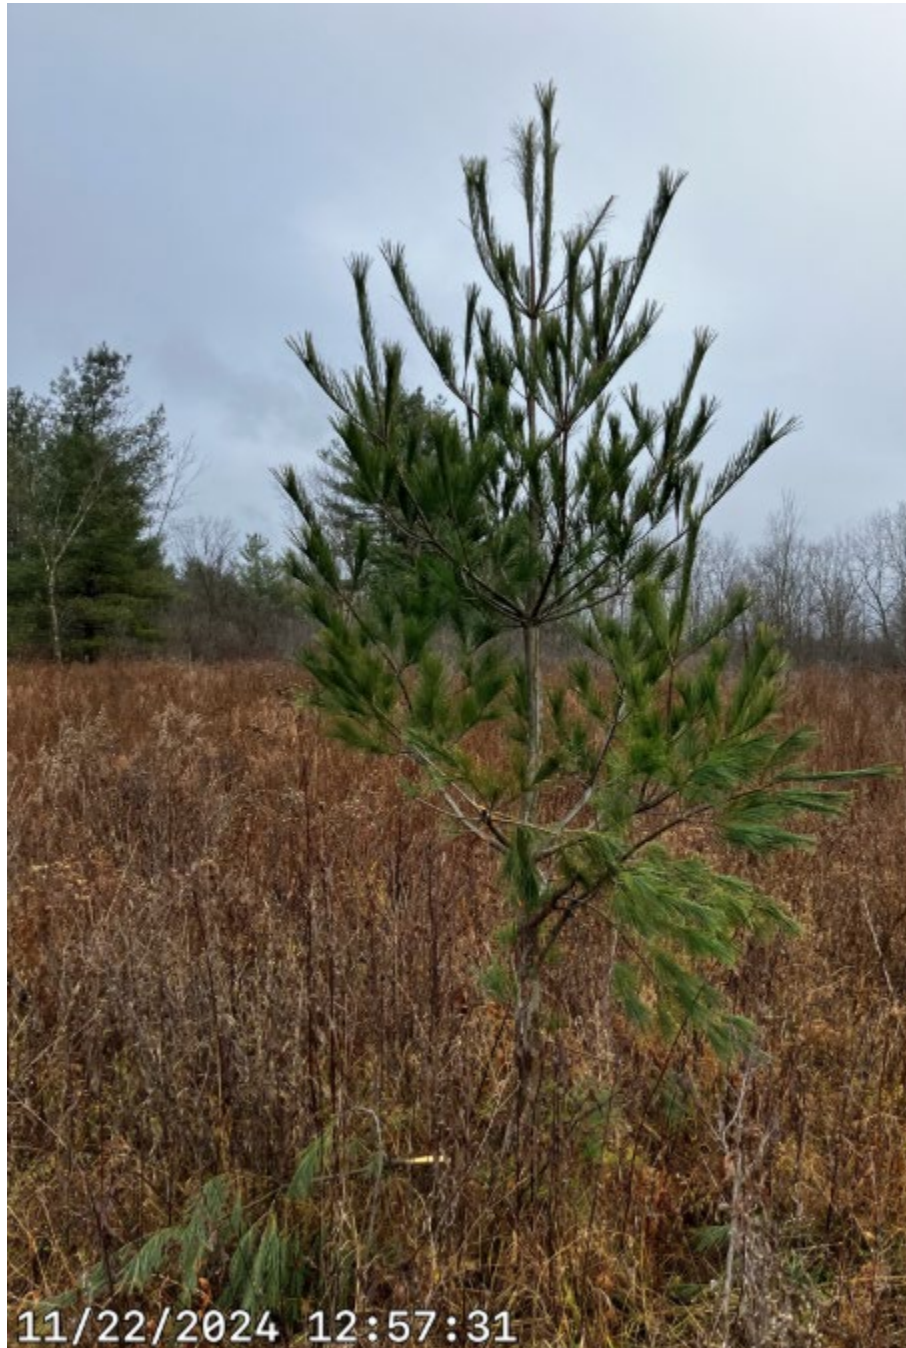
Photograph 2: Tree ID 2

Eastern white pine (*Pinus strobus*)

Species Filter: Growth Habit	Shrub
Select Tree	Pinus strobus, eastern white pine, Tree
Species	Pinus strobus
Common Name	eastern white pine
DBH (inches)	1.6
Crown Position	Dominant
Condition	Fair
Health	Healthy
Risk	Low
Notes	Tree is approximately 9' tall, showing damage from deer.
Photos

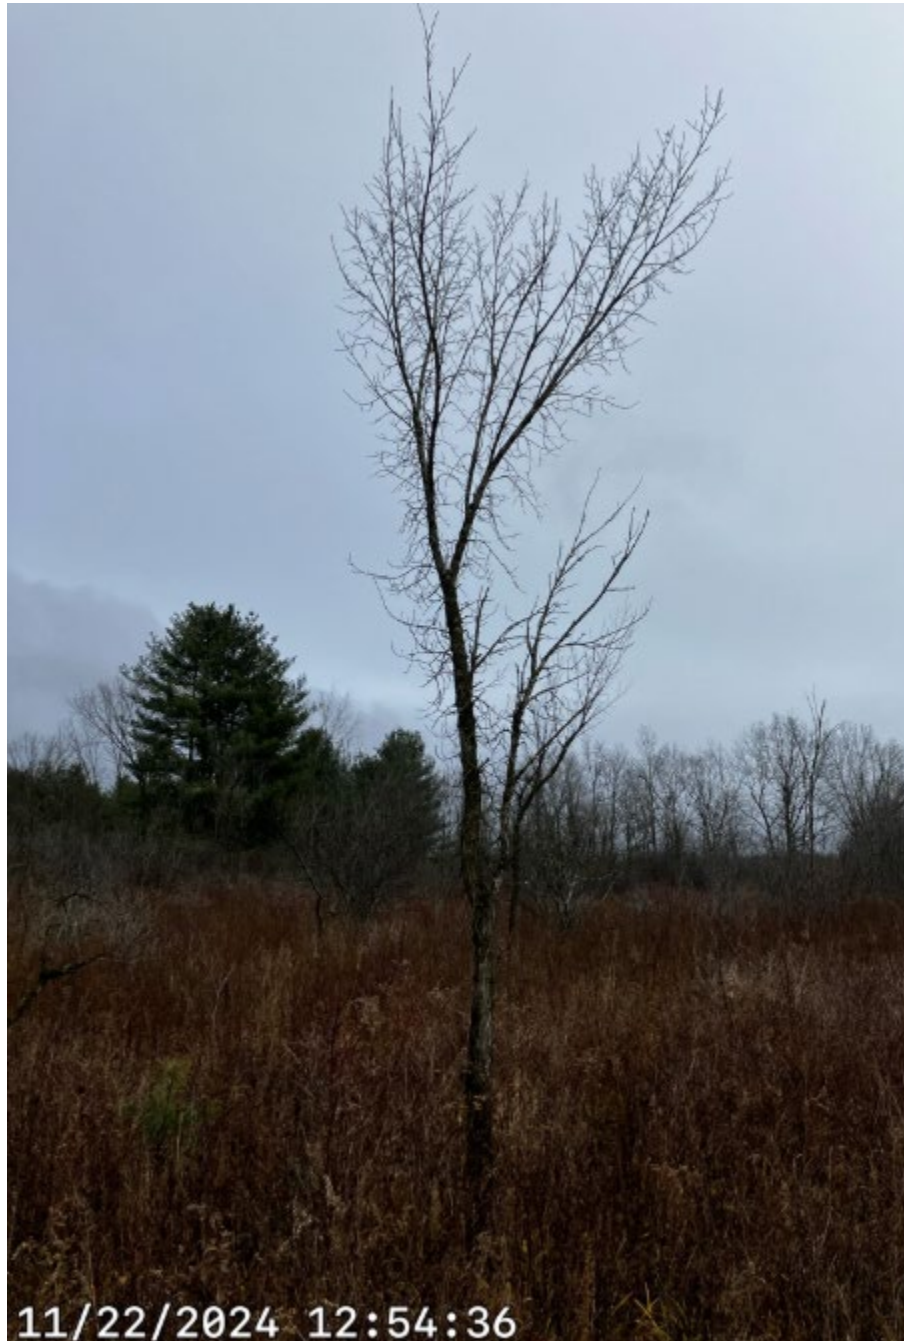
Photograph 3: Tree ID 3

American elm

Species Filter: Growth Habit	Tree
Select Tree	Ulmus americana, American elm, Tree
Species	Ulmus americana
Common Name	American elm
DBH (inches)	3.9
Crown Position	Dominant
Condition	Fair
Health	Declining
Risk	Low
Notes	Tree is approximately 20' tall
Photos

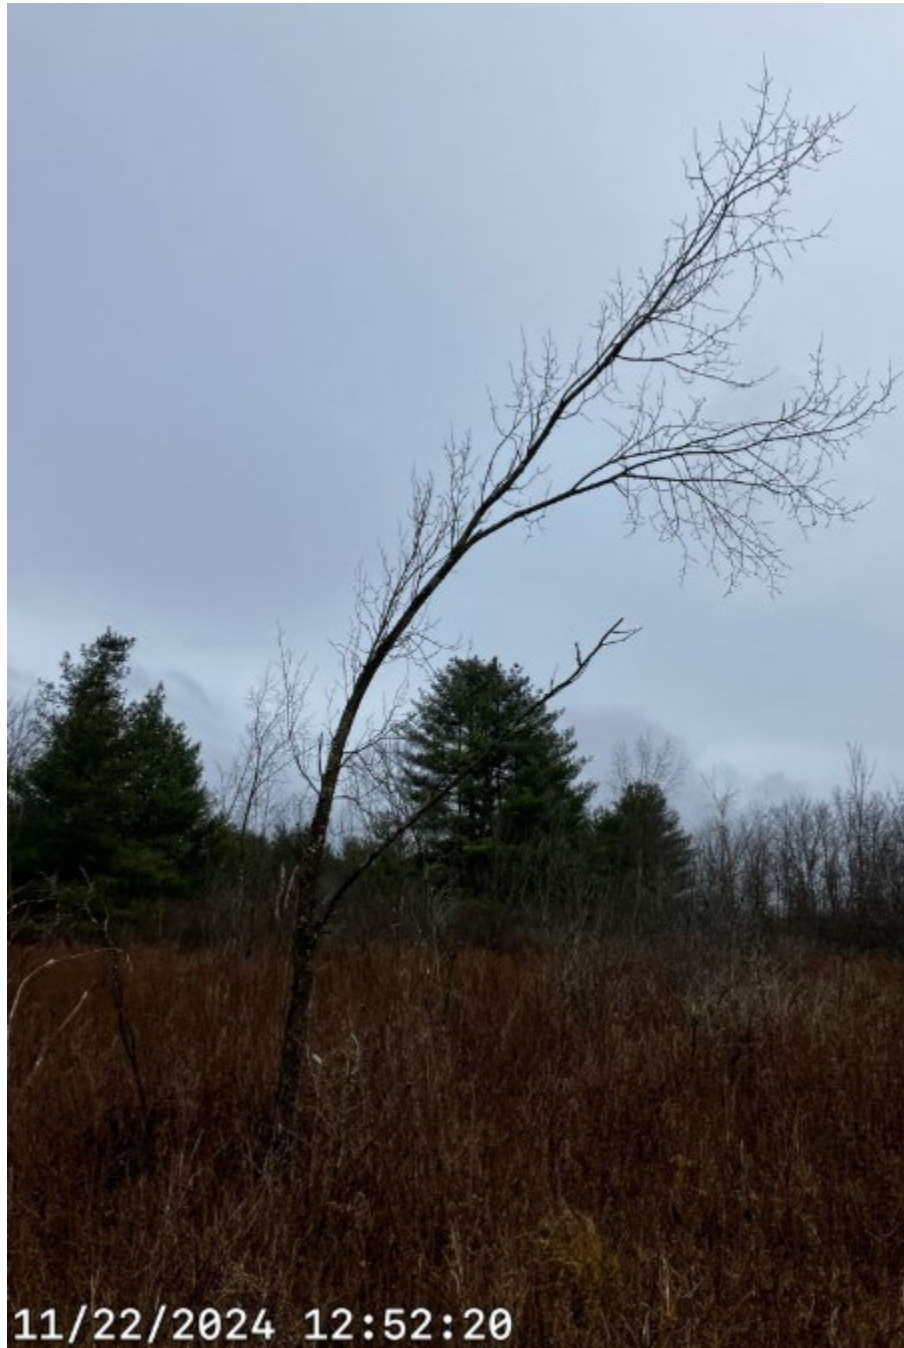
Photograph 4: Tree ID 4

American elm

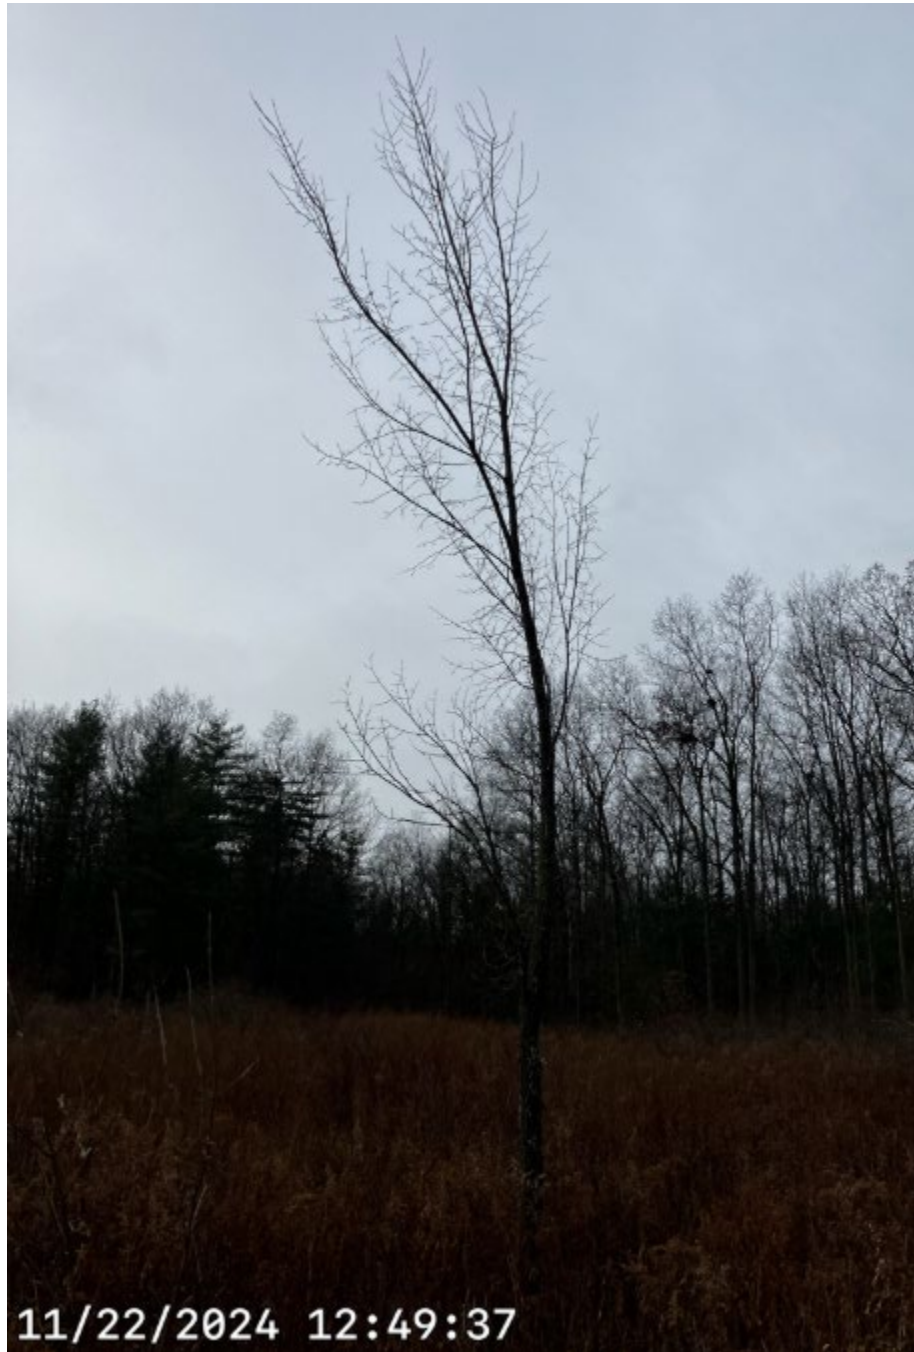
Photograph 5: Tree ID 5

American elm

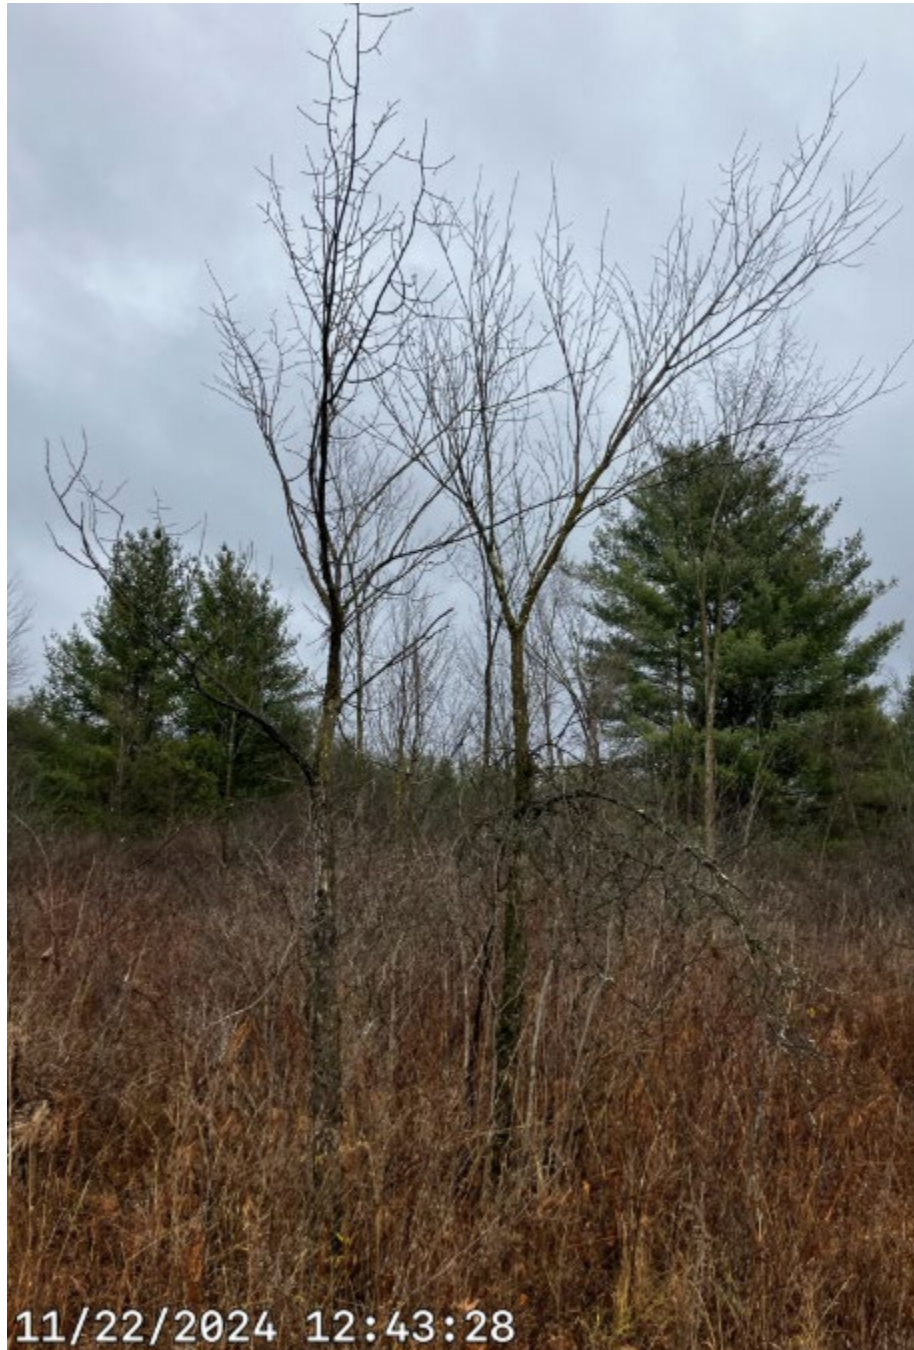
Photograph 6: Tree ID 6 and 7

*Tree is located just outside of both the wetland and the ROW.

American elm

Species Filter: Growth Habit	Tree
Select Tree	Ulmus americana, American elm, Tree
Species	Ulmus americana
Common Name	American elm
DBH (inches)	3.7
Crown Position	Dominant
Condition	Fair
Health	Declining
Risk	Low
Notes	Tree appears to be declining and is approximately 15' tall
Photos

Species Filter: Growth Habit	Tree
Select Tree	Ulmus americana, American elm, Tree
Species	Ulmus americana
Common Name	American elm
DBH (inches)	3.5
Crown Position	Co-dominant
Condition	Dying
Health	Poor
Risk	Low
Notes	Tree appears to be dying or dead. Approximately 15' tall.
Photos

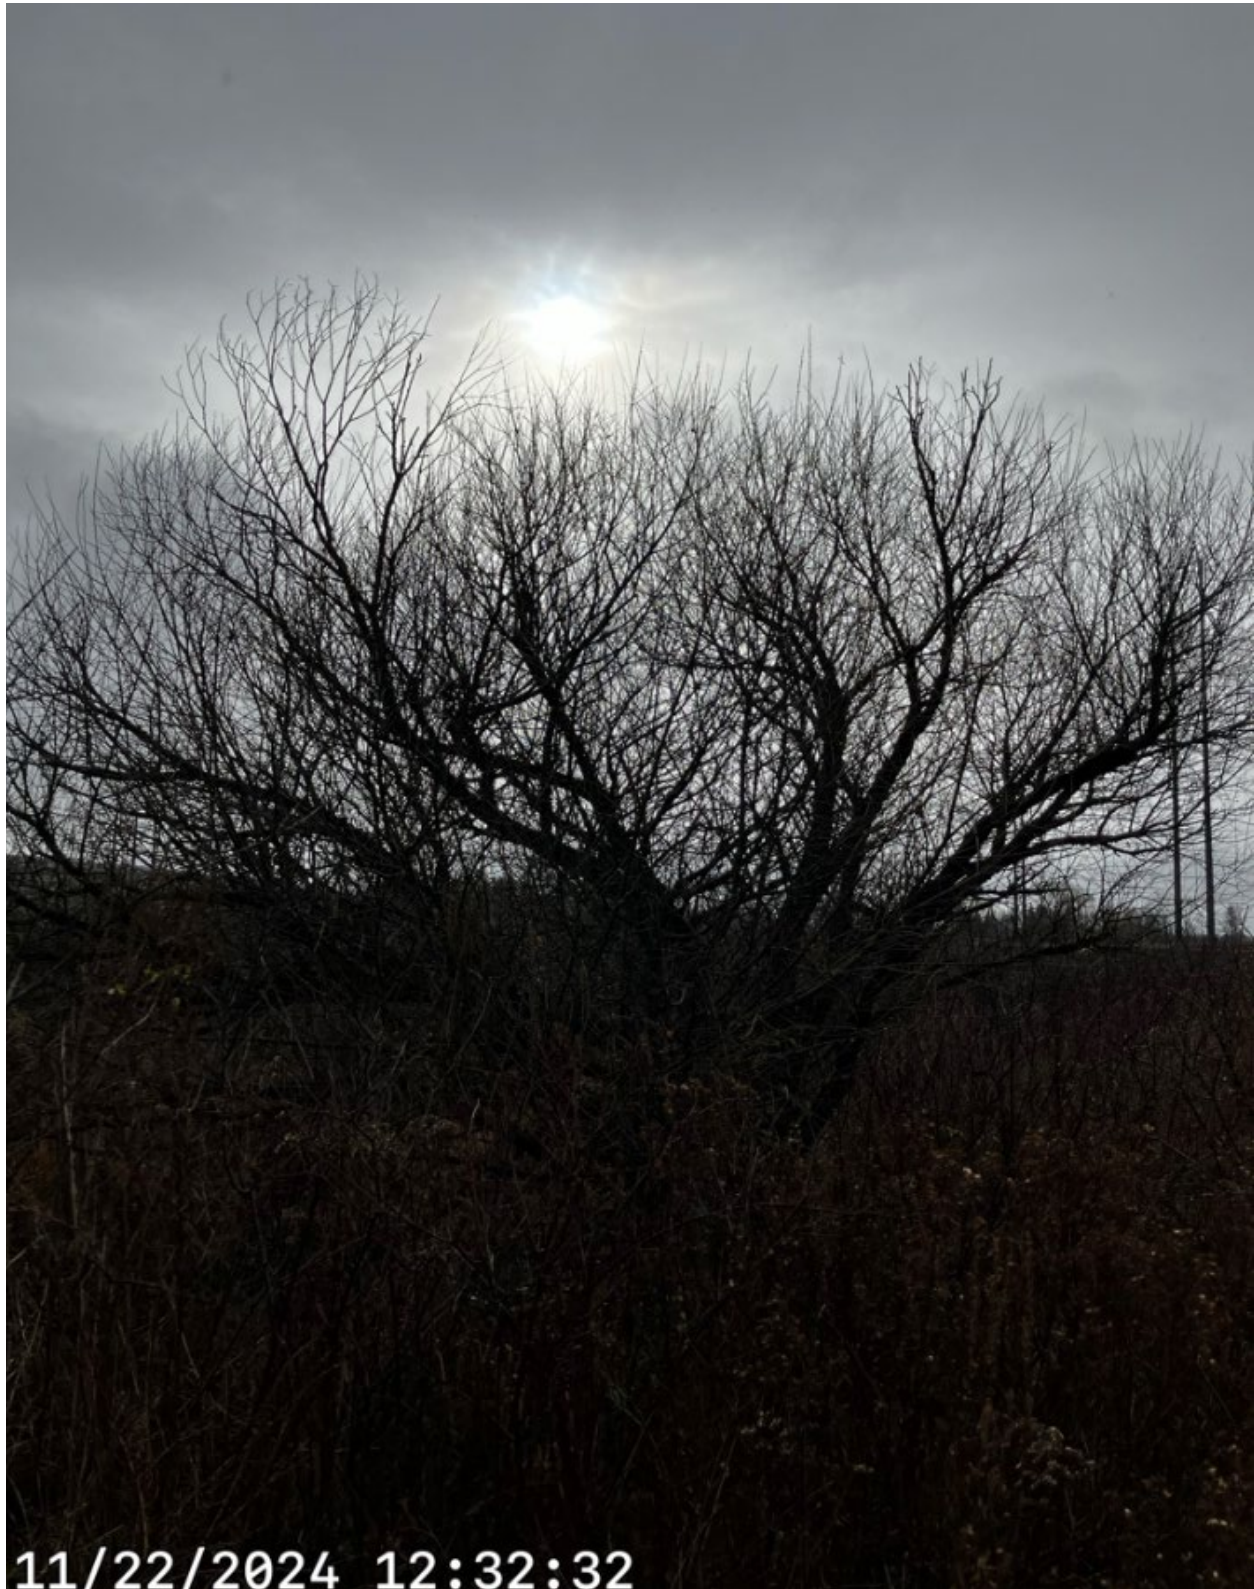
Photograph 7: Tree ID 8

Black willow (*Salix nigra*)

Species Filter: Growth Habit	Tree
Select Tree	Salix nigra, black willow, Tree
Species	Salix nigra
Common Name	black willow
DBH (inches)	9.2
Crown Position	Dominant
Condition	Fair
Health	Healthy
Risk	Low
Notes	Tree is multi-trunked, about 15' tall.
Photos

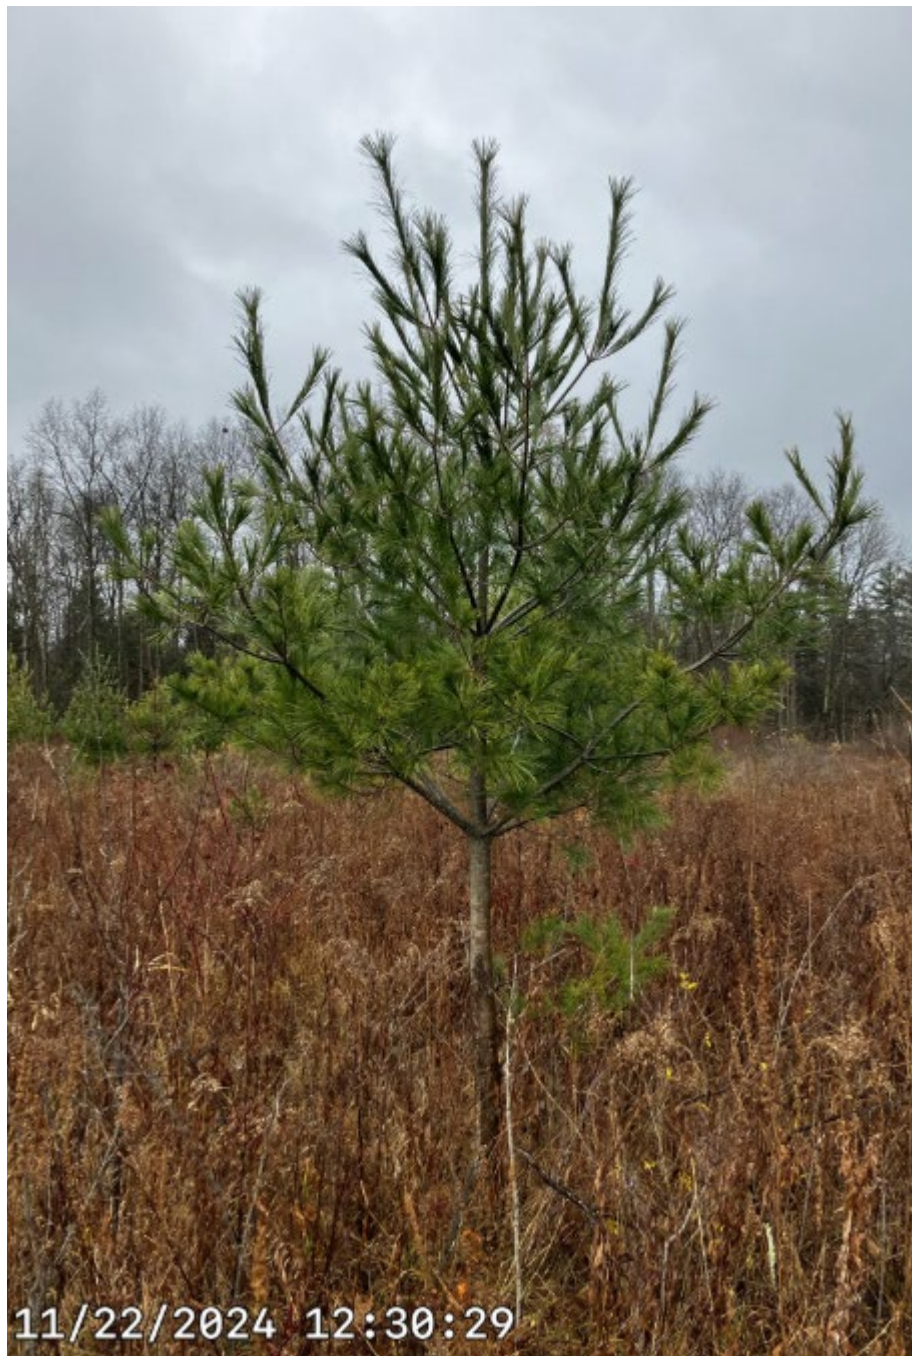
Photograph 8: Tree ID 9

Eastern white pine (*Pinus strobus*)

Species Filter: Growth Habit	Shrub
Select Tree	Pinus strobus, eastern white pine, Tree
Species	Pinus strobus
Common Name	eastern white pine
DBH (inches)	2.8
Crown Position	Dominant
Condition	Fair
Health	Healthy
Risk	Low
Notes	Shrub is 10' tall, showing trunk damage from deer.
Photos

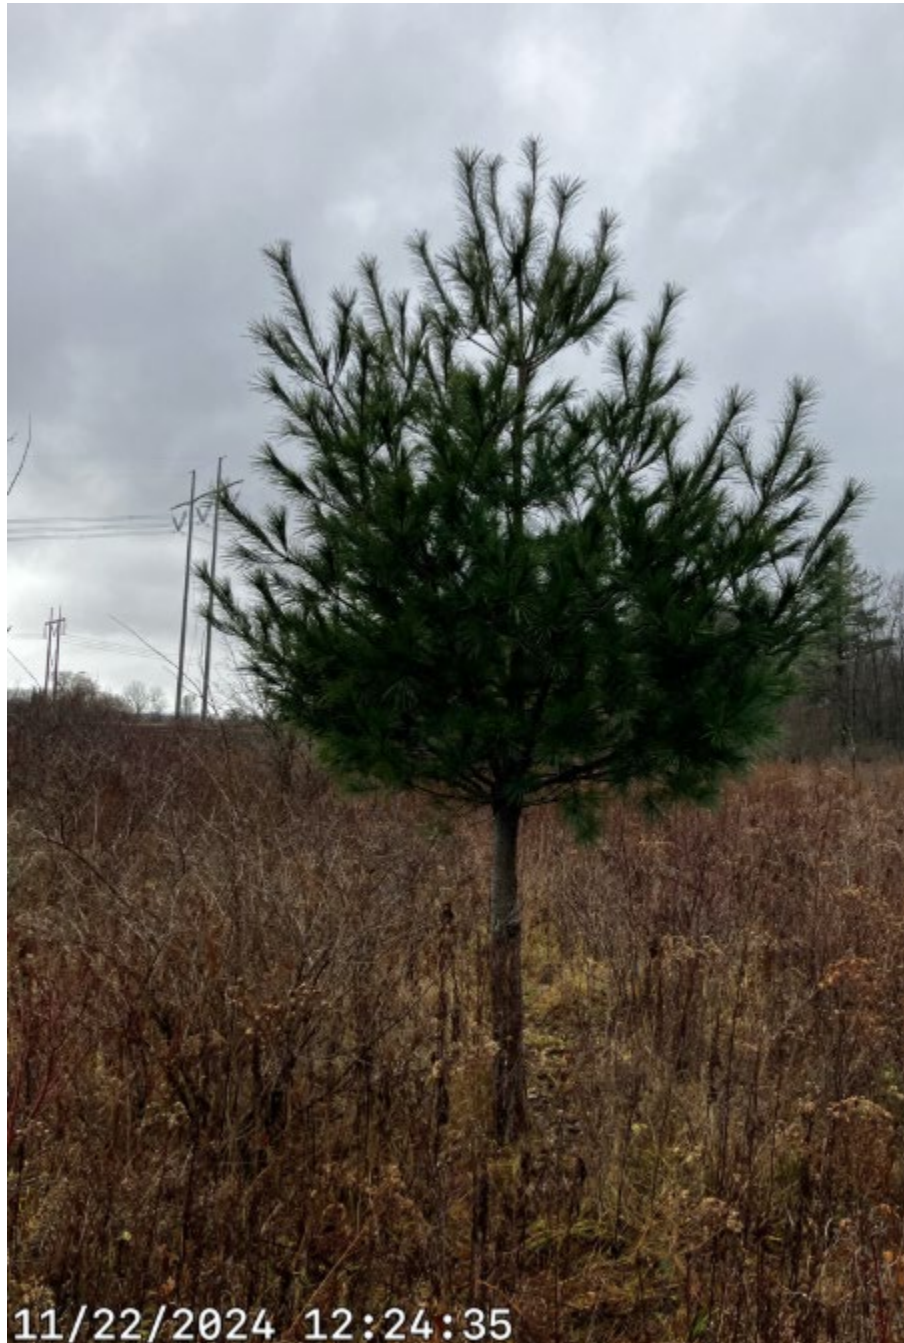
Photograph 9: Tree ID 10

Eastern white pine

Species Filter: Growth Habit	Tree
Select Tree	Pinus strobus, eastern white pine, Tree
Species	Pinus strobus
Common Name	eastern white pine
DBH (inches)	3.9
Crown Position	Dominant
Condition	Fair
Health	Declining
Risk	Low
Notes	Tree is approximately 13' tall. Trunk is showing damage from deer.
Photos

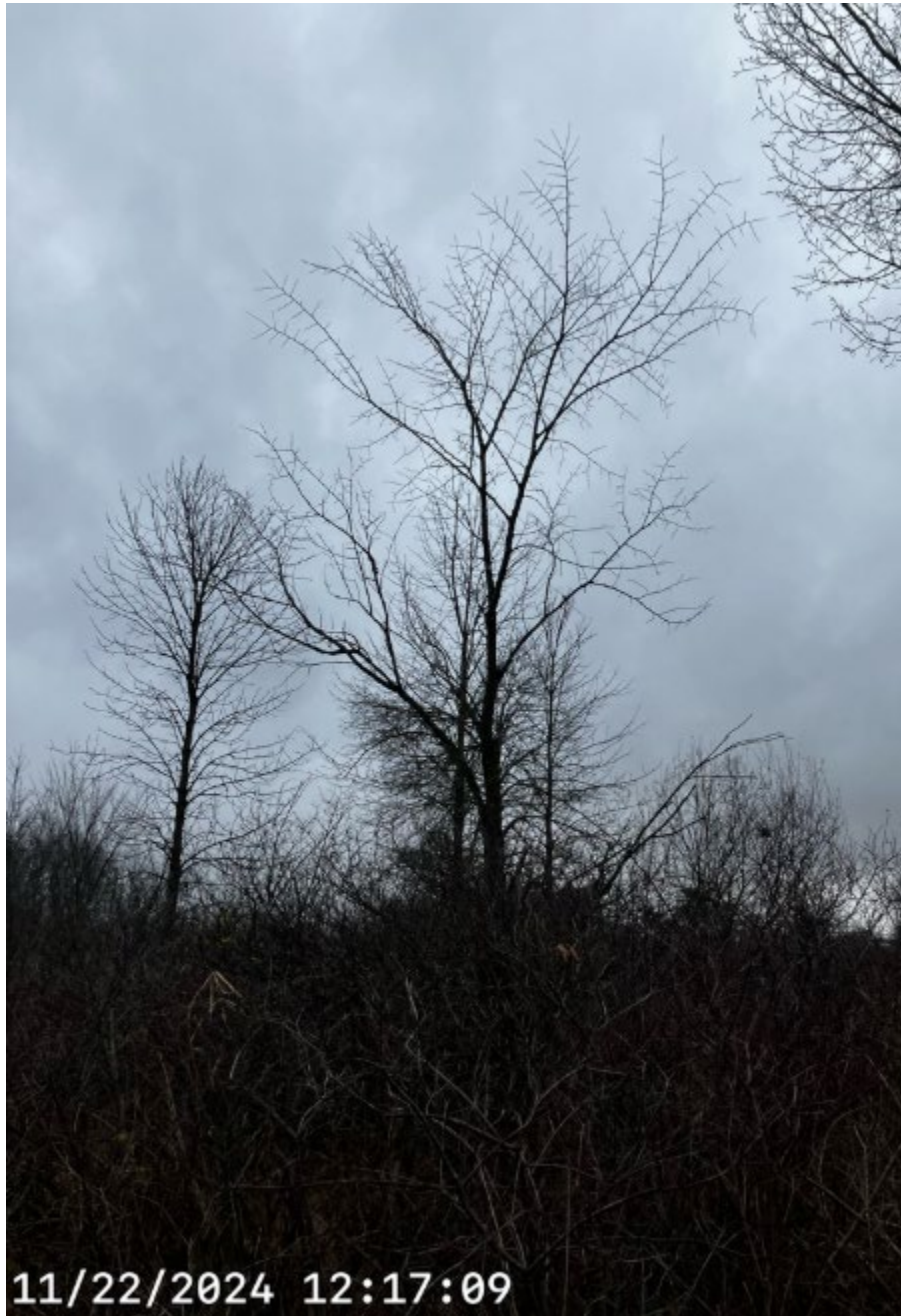
Photograph 10: Tree ID 11

American elm

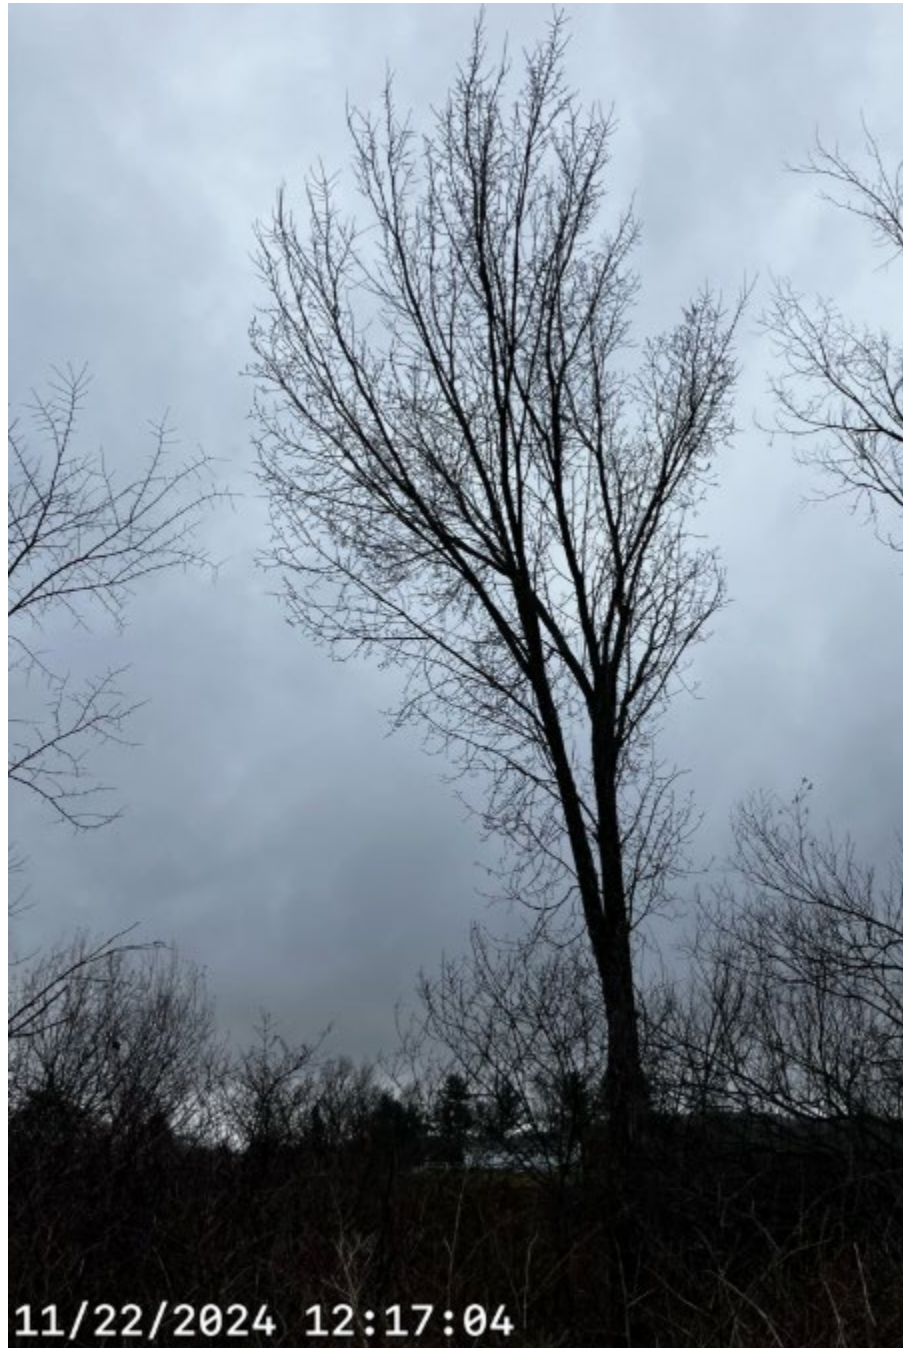
Photograph 11: Tree ID 12

American elm

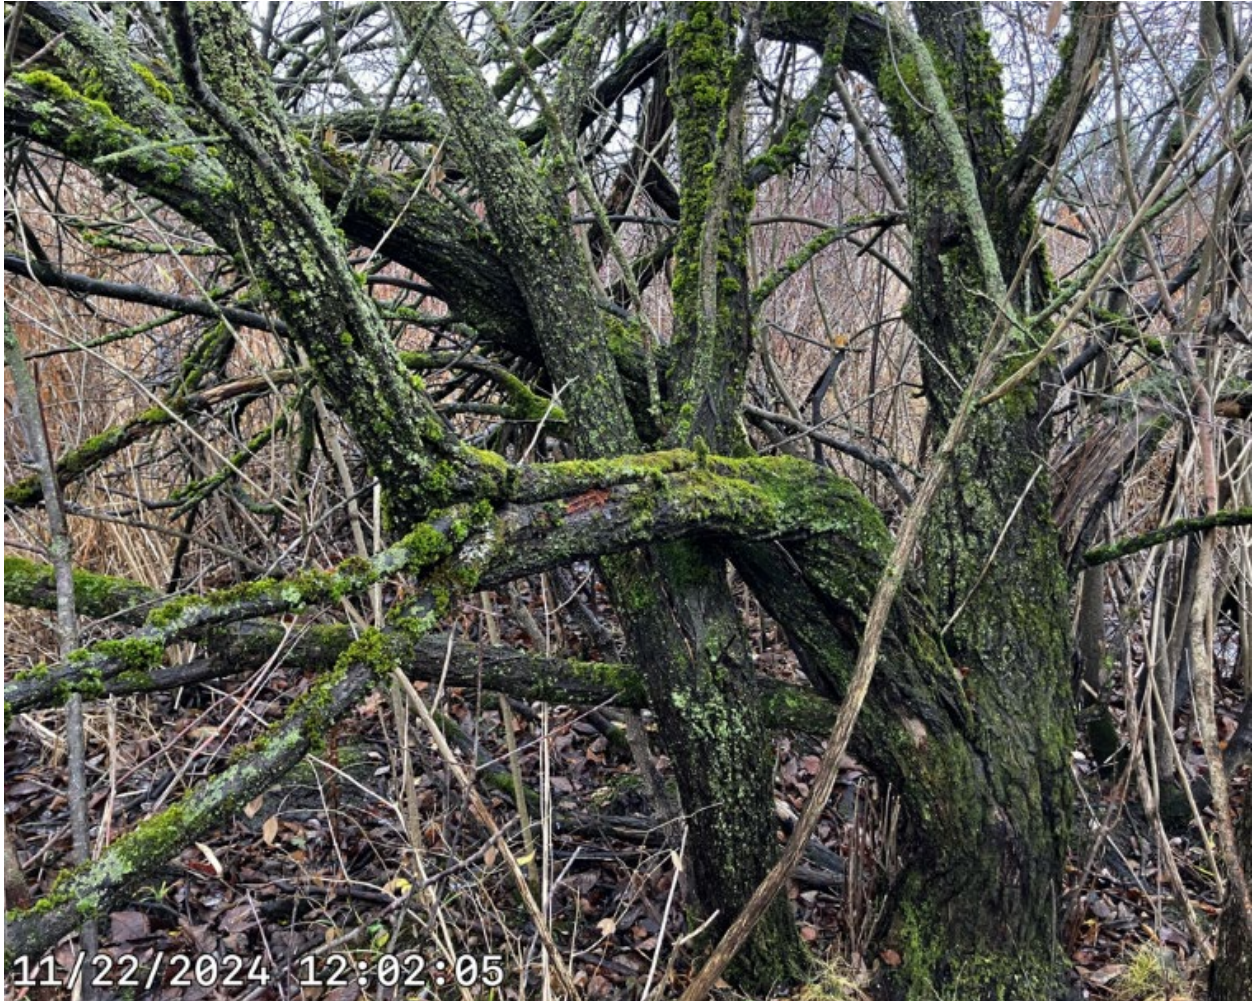
Photograph 12: Tree IDs 13 and 14

Black willow

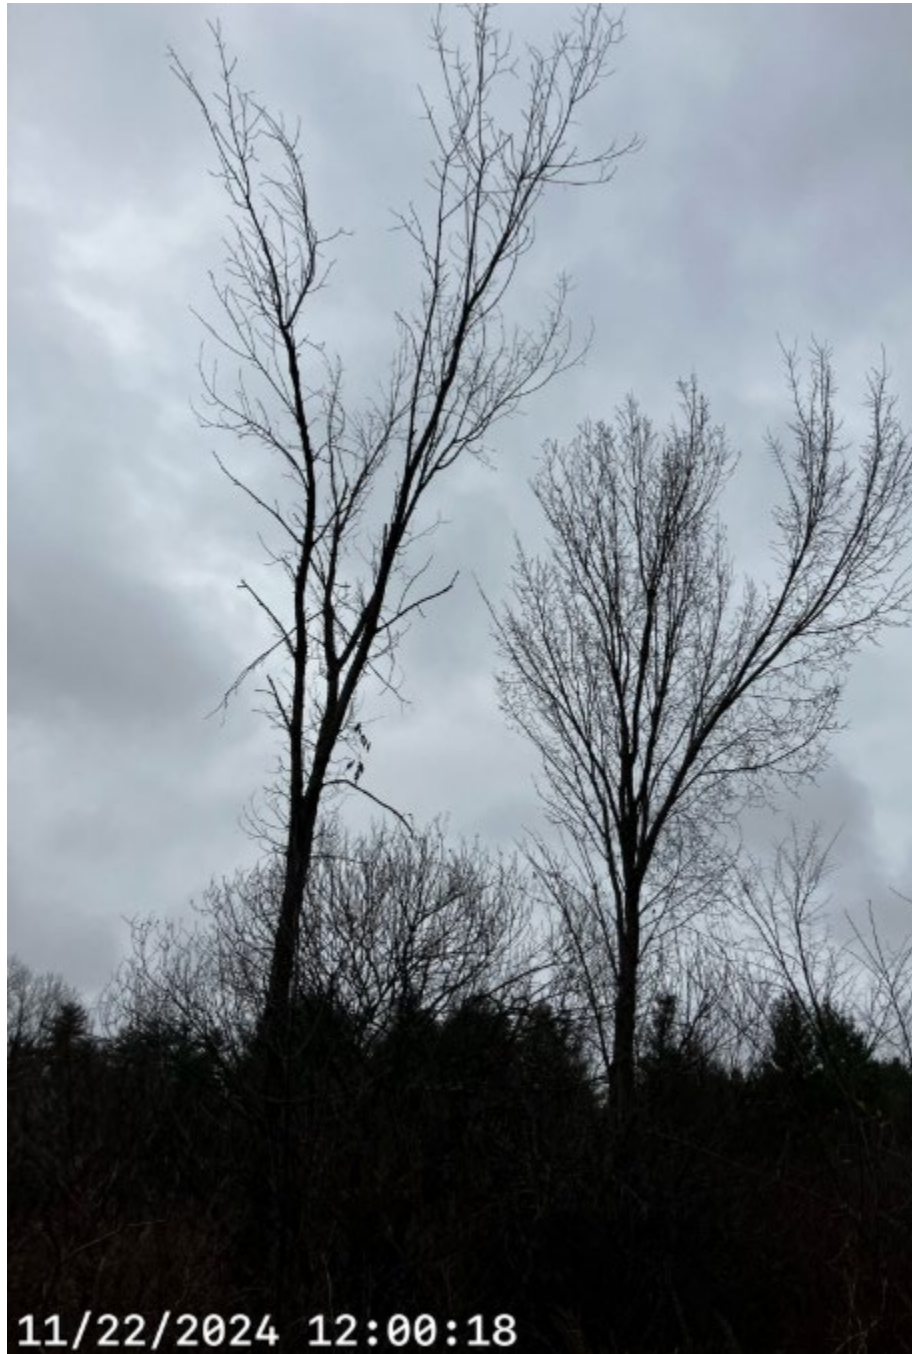
Photograph 13: Tree ID 15

American elm (*Ulmus americana*)

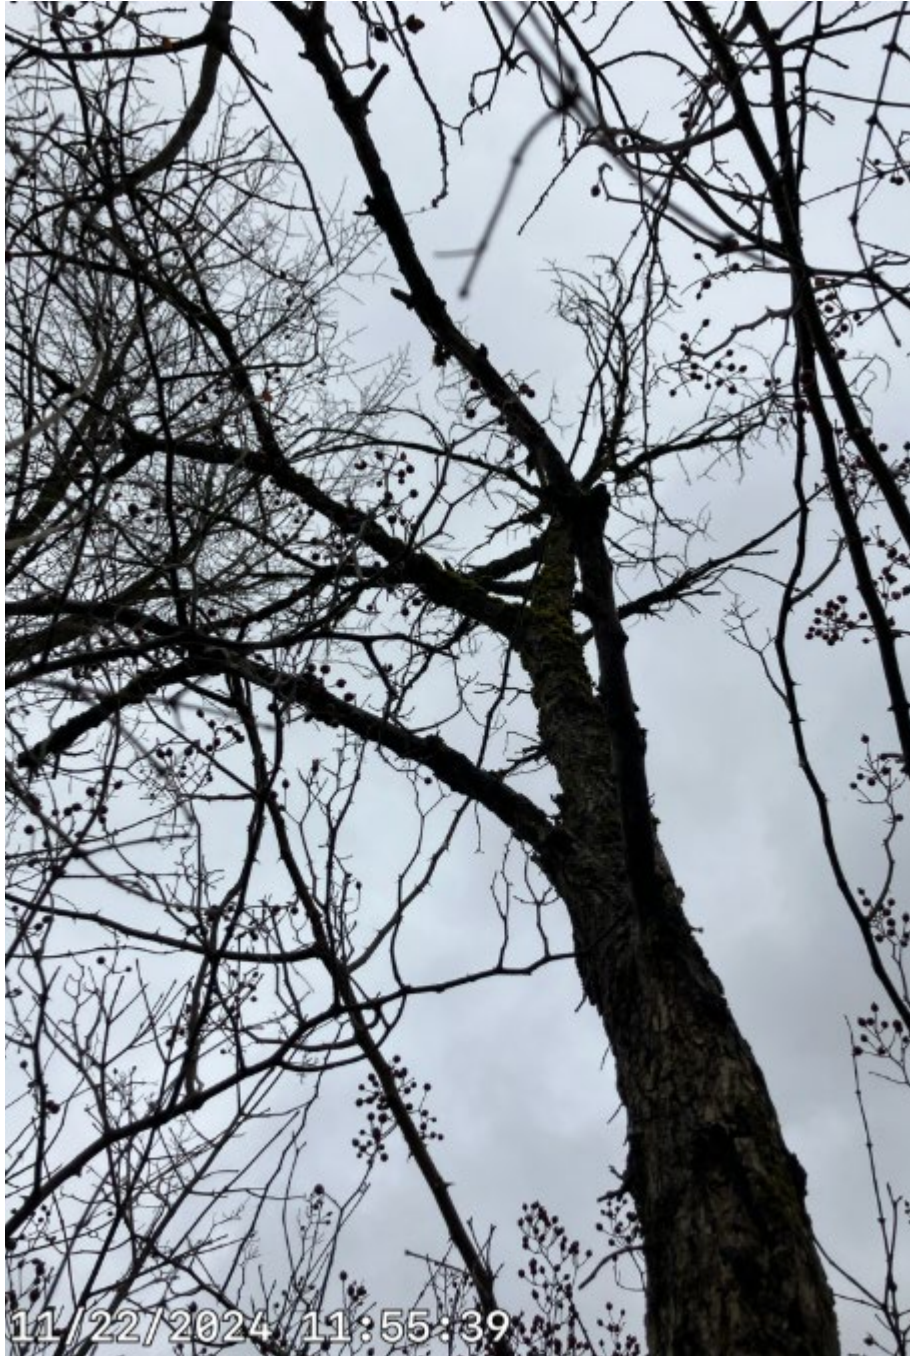
Photograph 14: Tree ID 16

American elm (*Ulmus americana*)

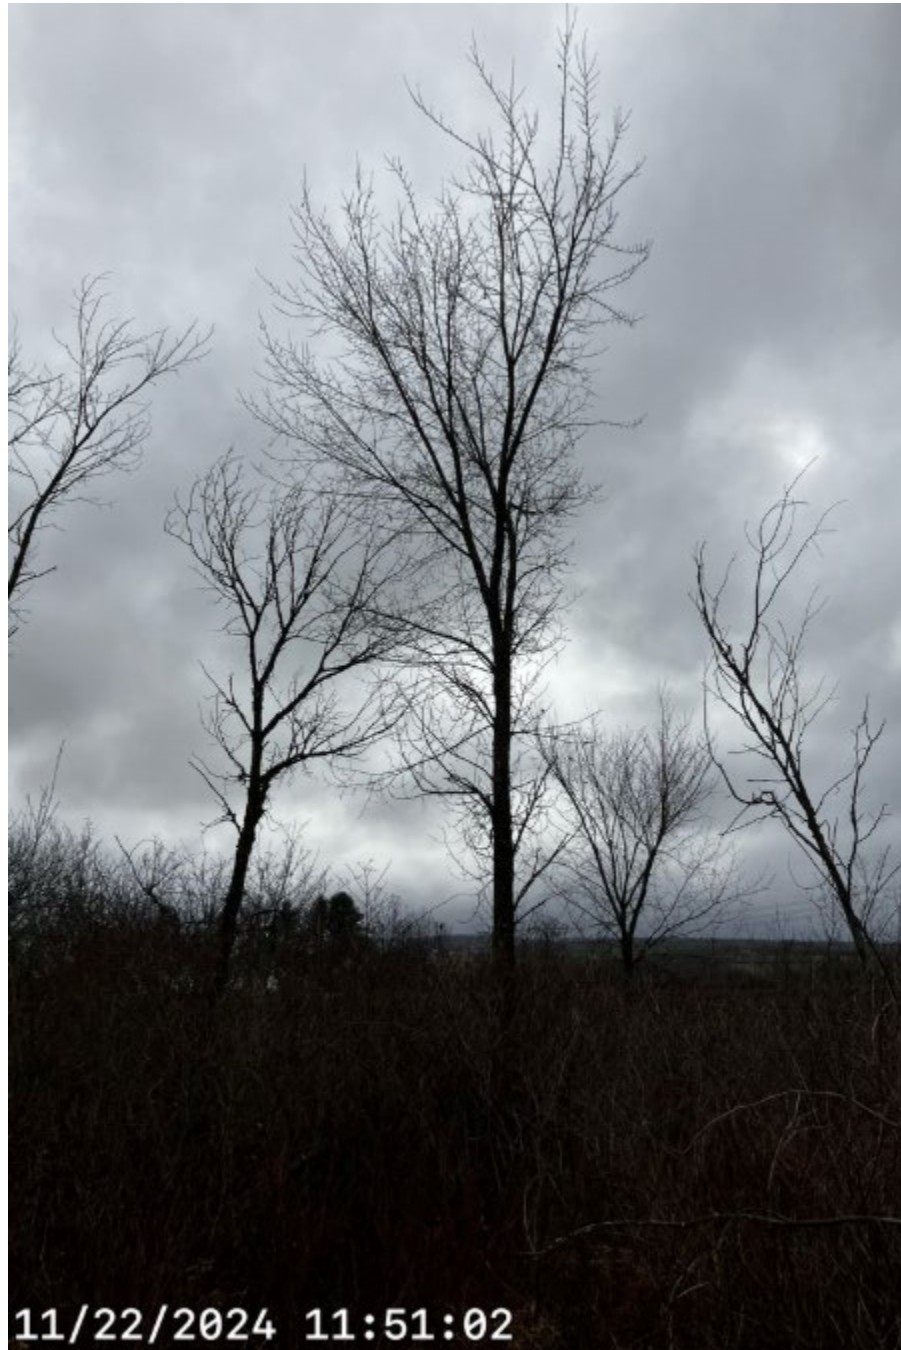
Photograph 15: Tree ID 17
American elm (*Ulmus americana*)

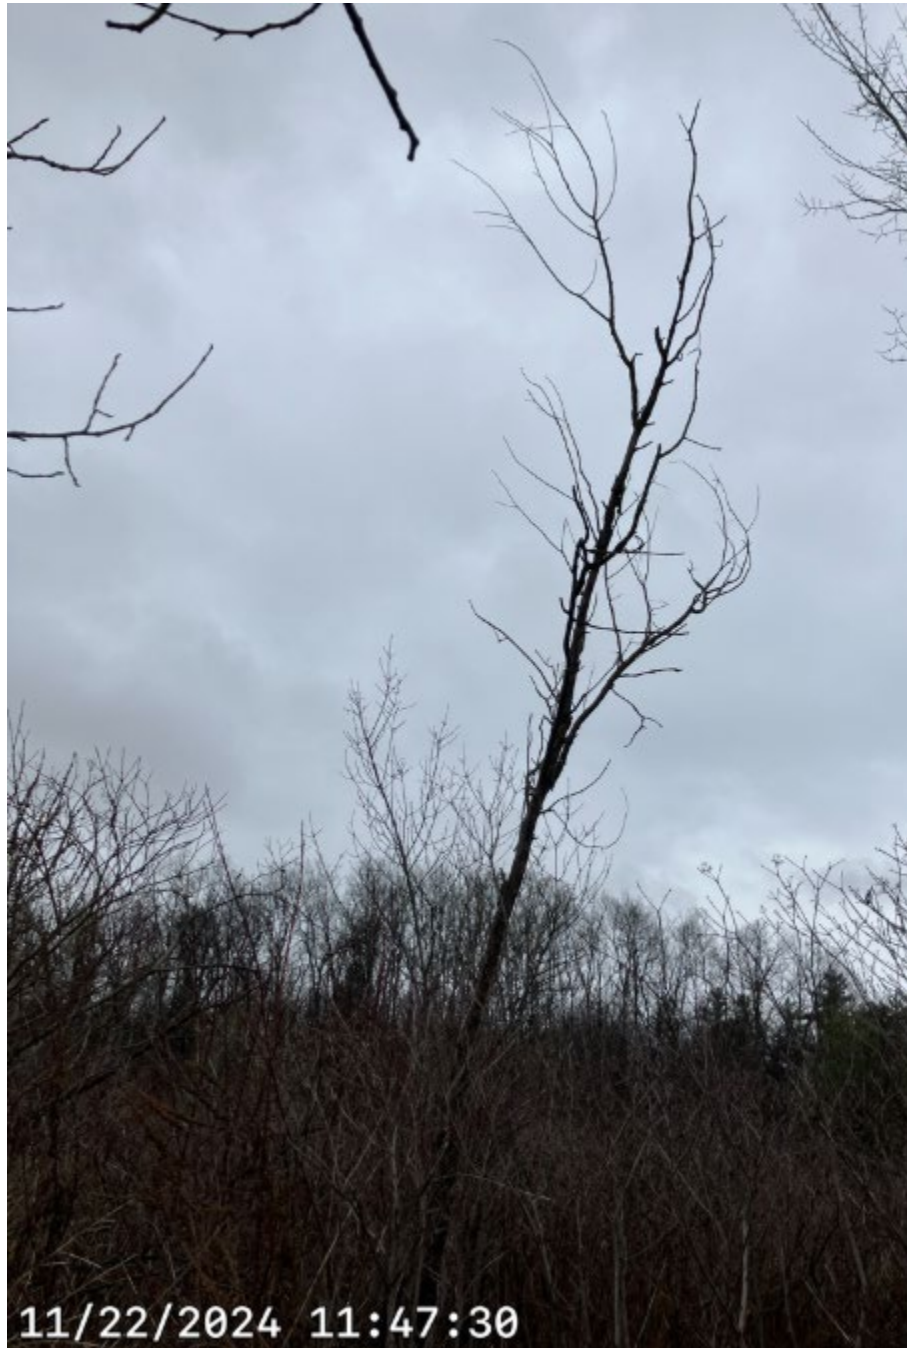
Photograph 16: Tree ID 18

American elm

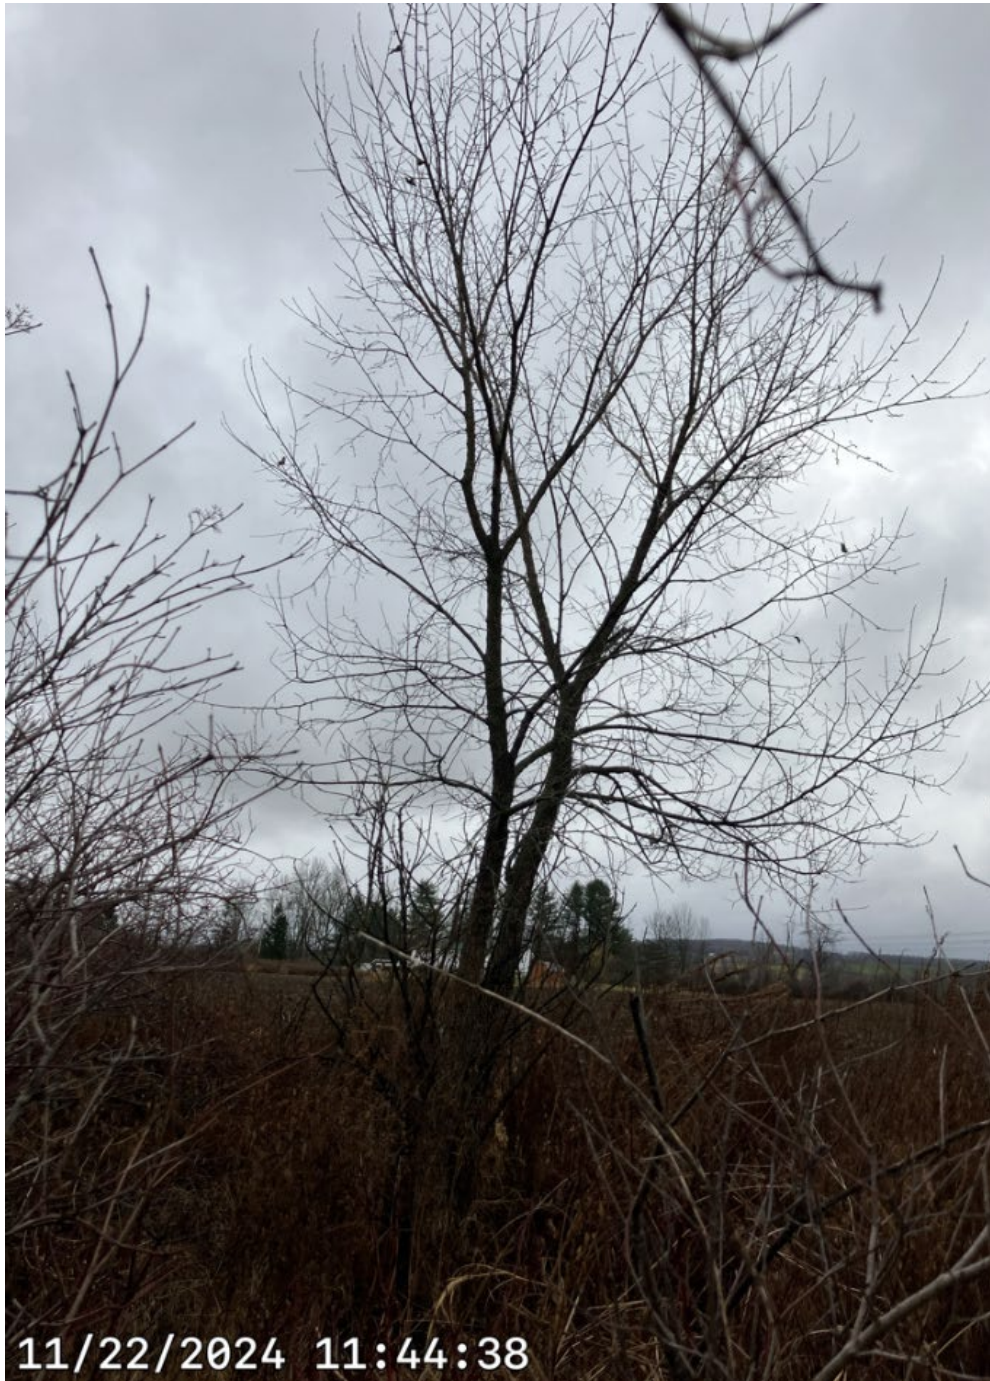
Photograph 17: Tree ID 19

American elm
