TREE SURVEY MEMORANDUM

MILL POINT SOLAR I PROJECT

TOWN OF GLEN
MONTGOMERY COUNTY, NEW YORK

DECEMBER 2024

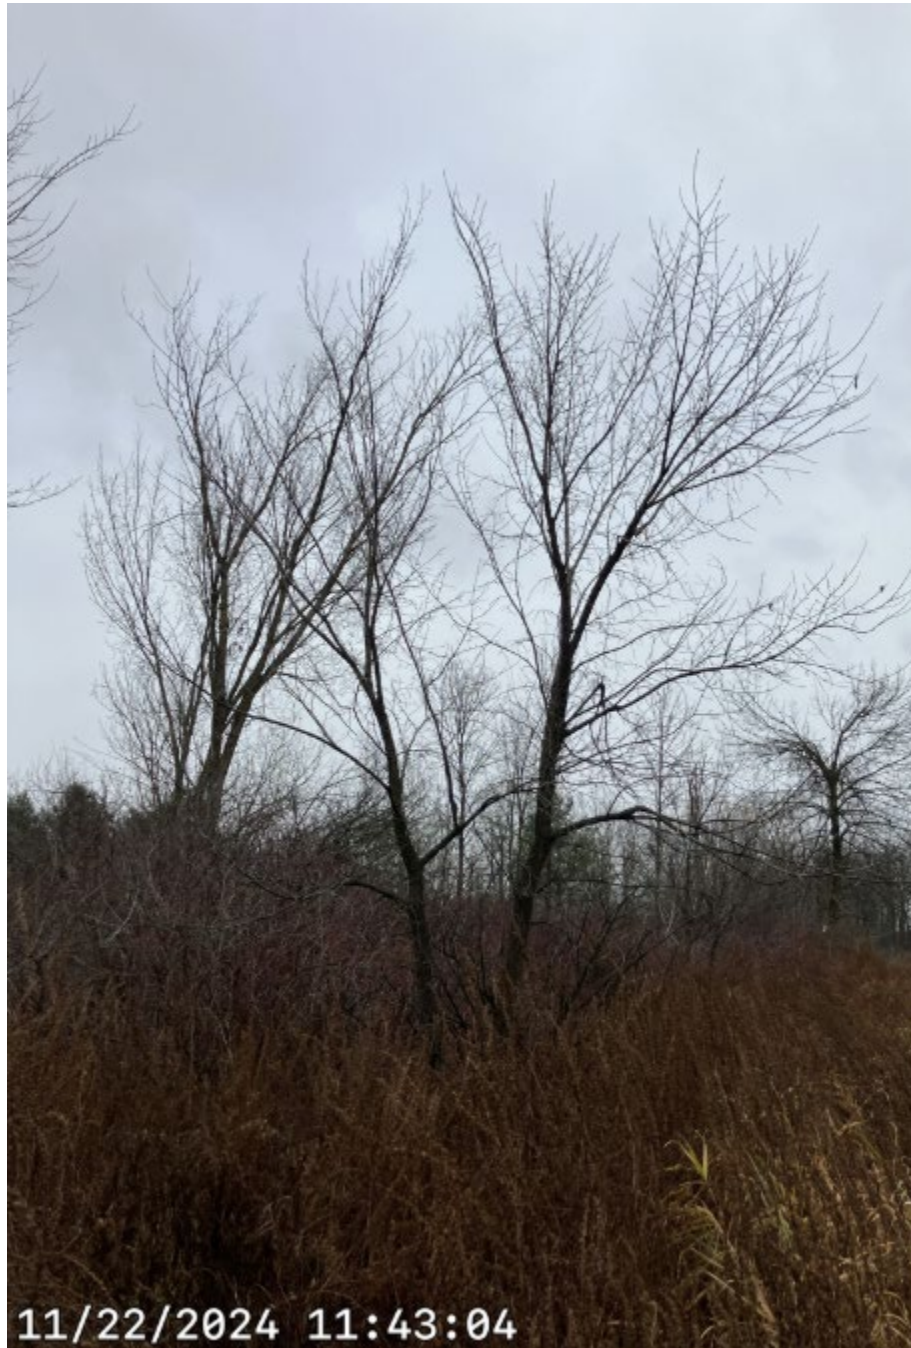
Photograph 18: Tree ID 20

American elm
