TREE SURVEY MEMORANDUM

MILL POINT SOLAR I PROJECT

TOWN OF GLEN
MONTGOMERY COUNTY, NEW YORK

DECEMBER 2024

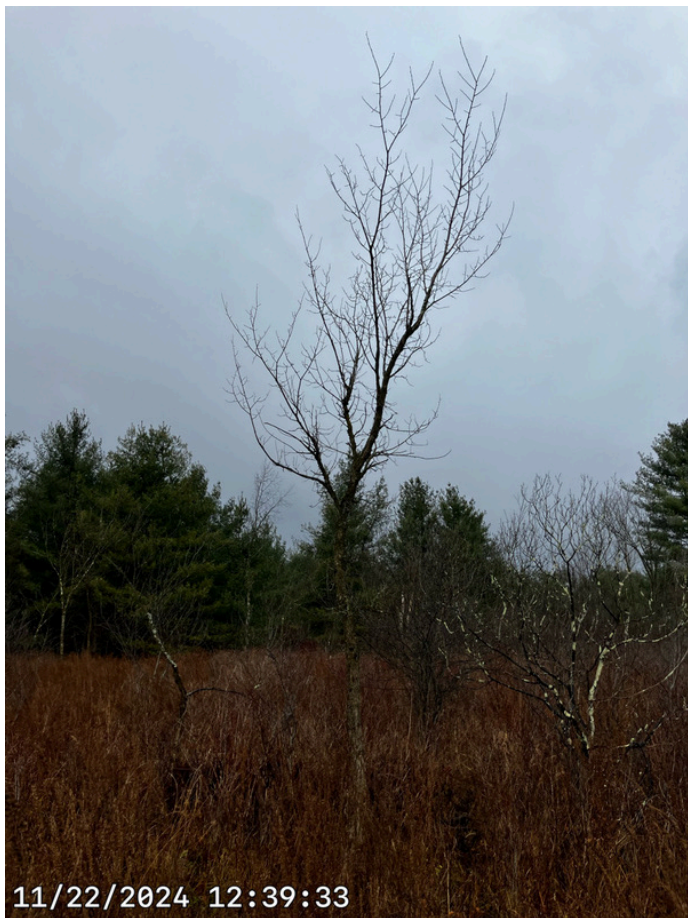
TREE ID 1

Species Filter: Growth Habit	Tree
Select Tree	Ulmus americana, American elm, Tree
Species	Ulmus americana
Common Name	American elm
DBH (inches)	4.2
Crown Position	Dominant
Condition	Poor
Health	Poor
Risk	Low
Notes	Tree is approximately 15' tall
Photos

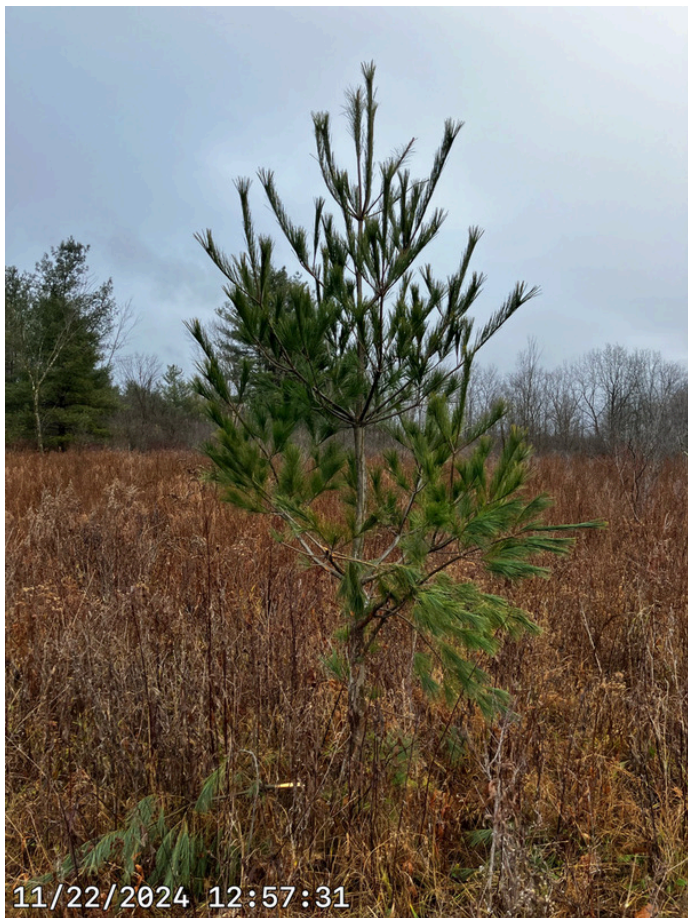
TREE ID 2

Species Filter: Growth Habit	Shrub
Select Tree	Pinus strobus, eastern white pine, Tree
Species	Pinus strobus
Common Name	eastern white pine
DBH (inches)	1.6
Crown Position	Dominant
Condition	Fair
Health	Healthy
Risk	Low
Notes	Tree is approximately 9' tall, showing damage from deer.
Photos

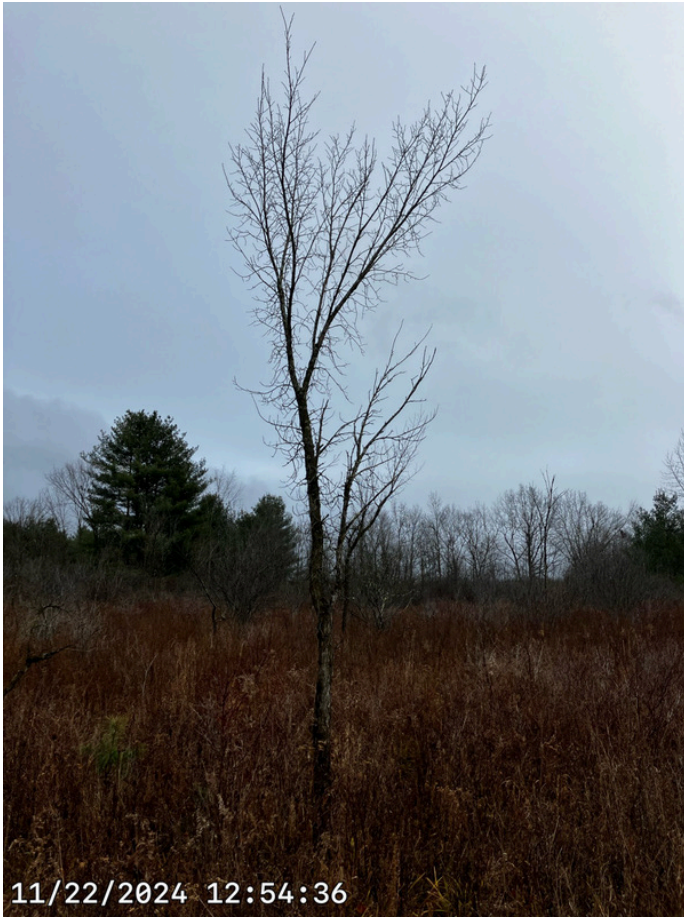
TREE ID 3

Species Filter: Growth Habit	Tree
Select Tree	Ulmus americana, American elm, Tree
Species	Ulmus americana
Common Name	American elm
DBH (inches)	3.9
Crown Position	Dominant
Condition	Fair
Health	Declining
Risk	Low
Notes	Tree is approximately 20' tall
Photos

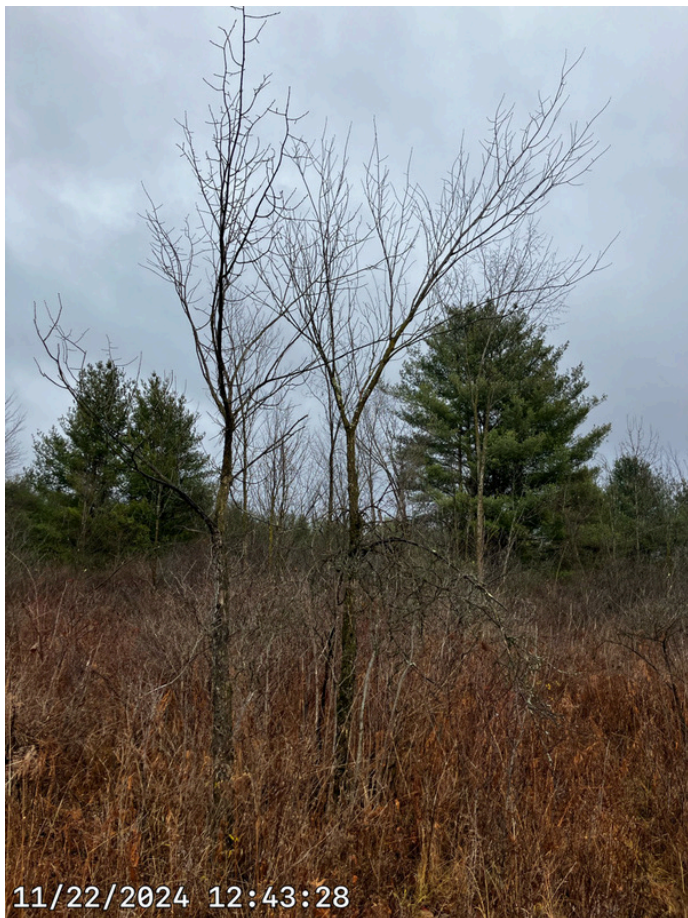
TREE ID 6

Species Filter: Growth Habit	Tree
Select Tree	Ulmus americana, American elm, Tree
Species	Ulmus americana
Common Name	American elm
DBH (inches)	3.7
Crown Position	Dominant
Condition	Fair
Health	Declining
Risk	Low
Notes	Tree appears to be declining and is approximately 15' tall
Photos

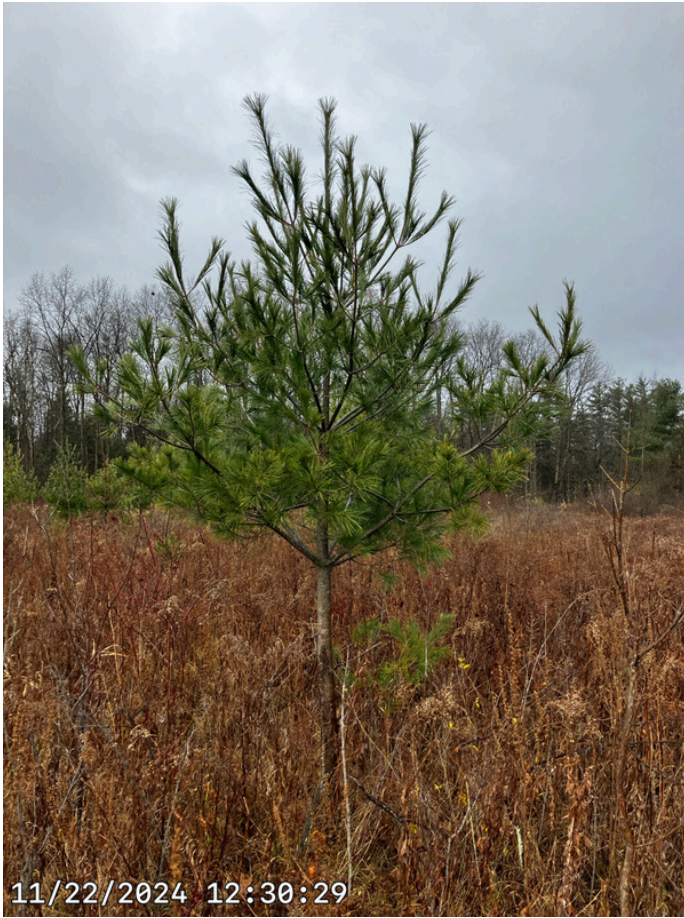
TREE ID 9

Species Filter: Growth Habit	Shrub
Select Tree	Pinus strobus, eastern white pine, Tree
Species	Pinus strobus
Common Name	eastern white pine
DBH (inches)	2.8
Crown Position	Dominant
Condition	Fair
Health	Healthy
Risk	Low
Notes	Shrub is 10' tall, showing trunk damage from deer.
Photos
