Historic Architectural Survey and Effects Report

Town of Glen, Montgomery County,
New York

October 2022

Mill Point Solar Project Prepared for:

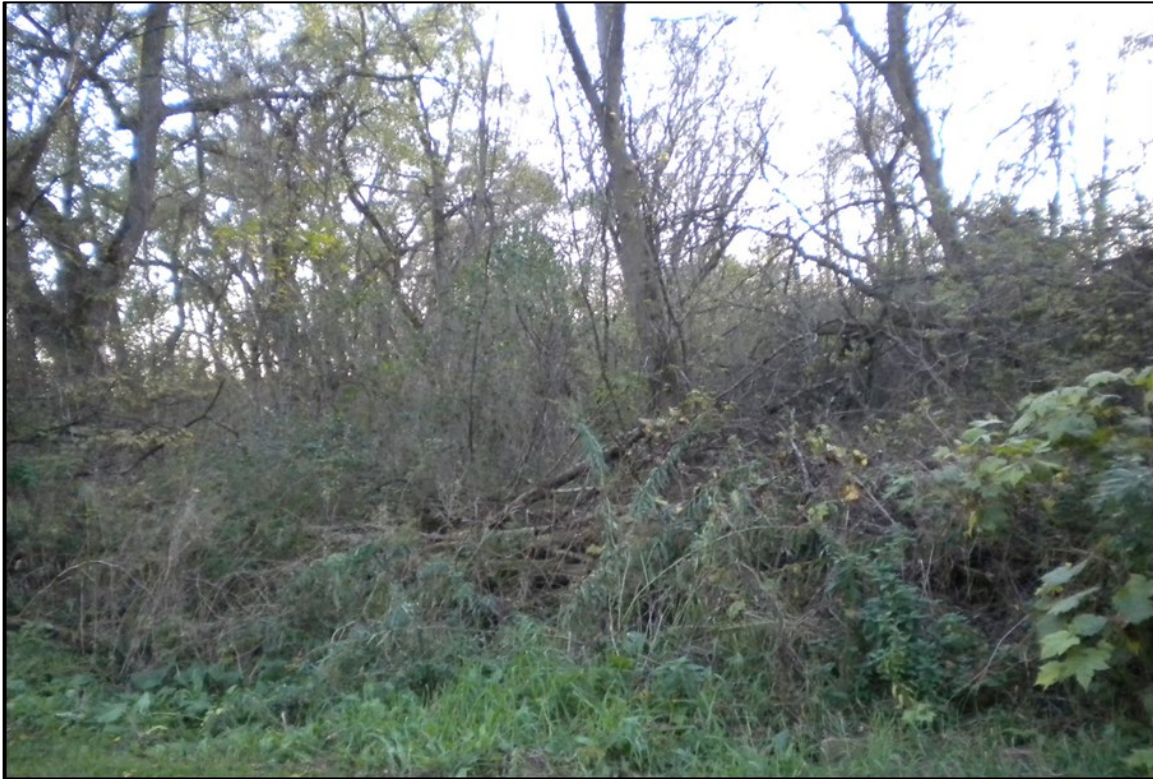
View from abandoned Erie Canal section at Hartley Lane looking southwest toward the Project area.

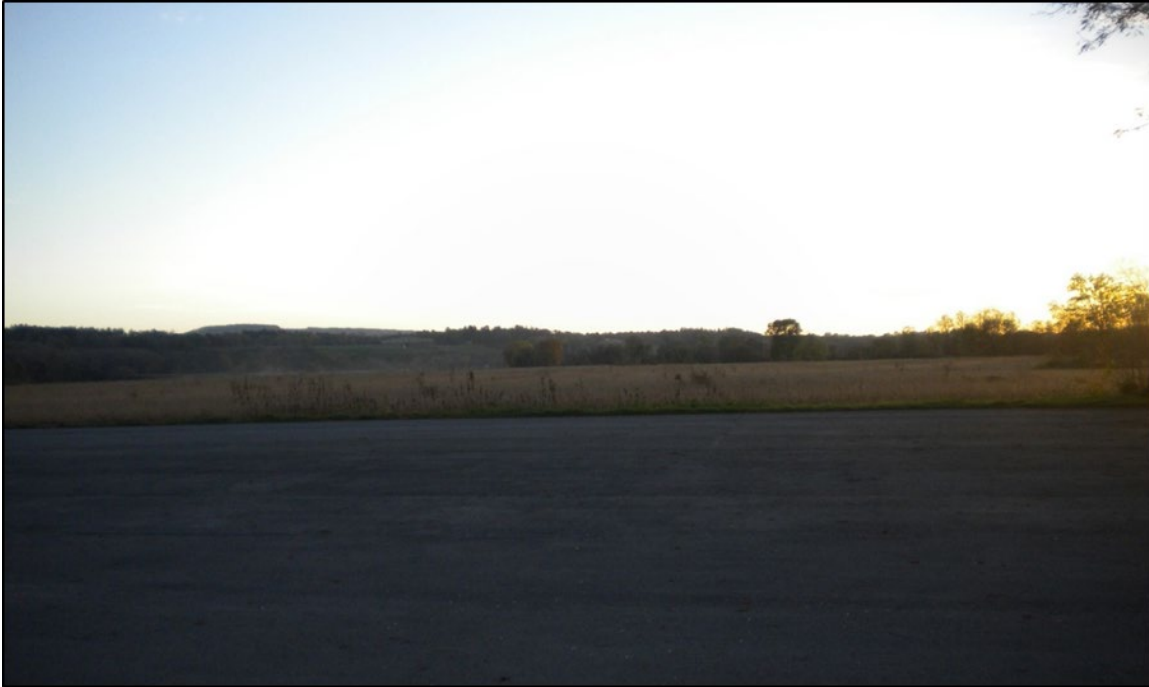
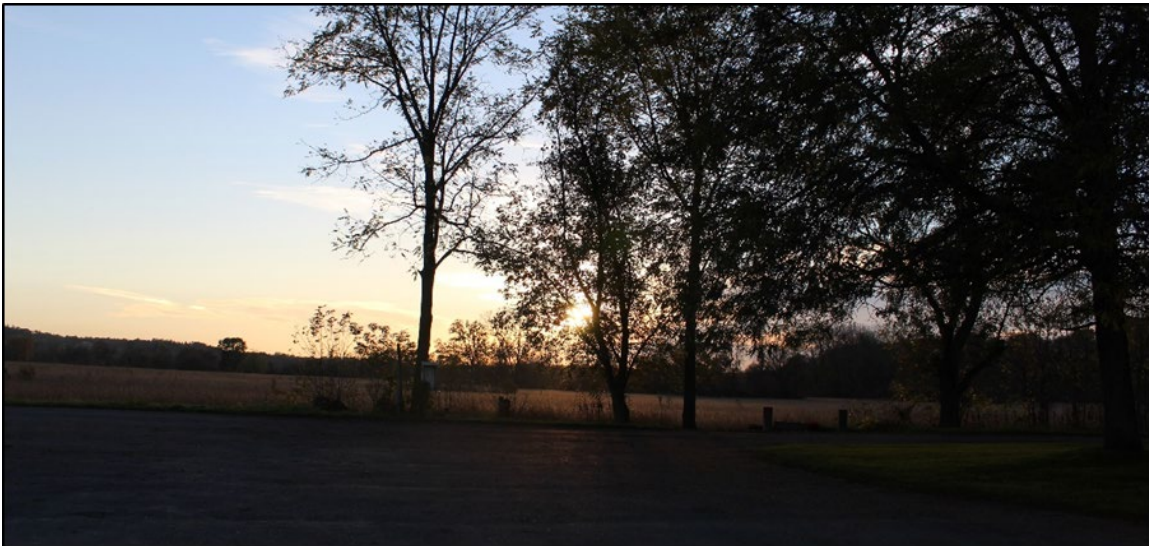
View from Hartley Lane public access looking southwest toward the Project area.

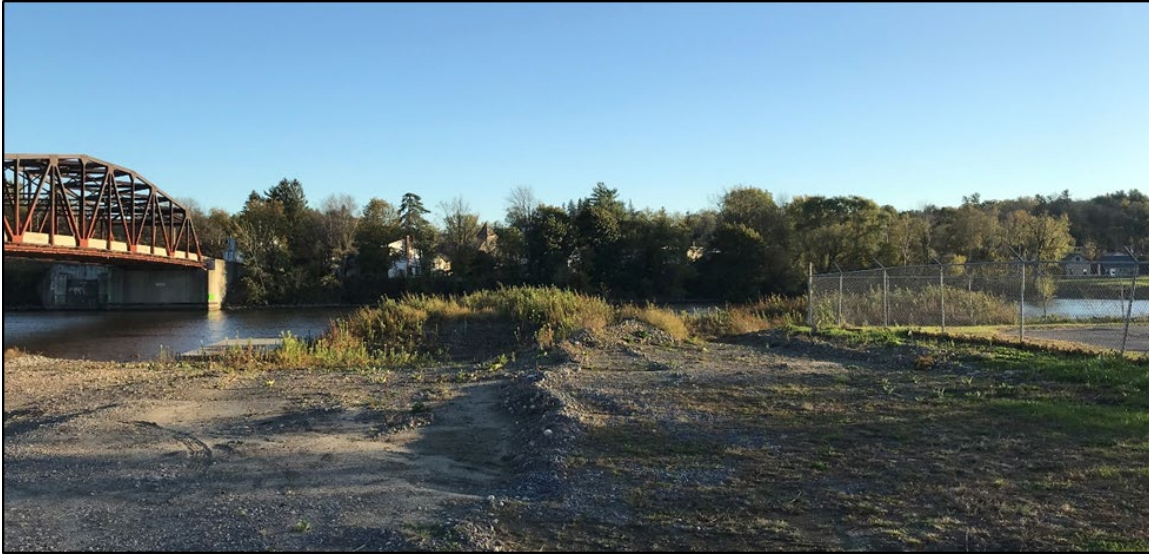
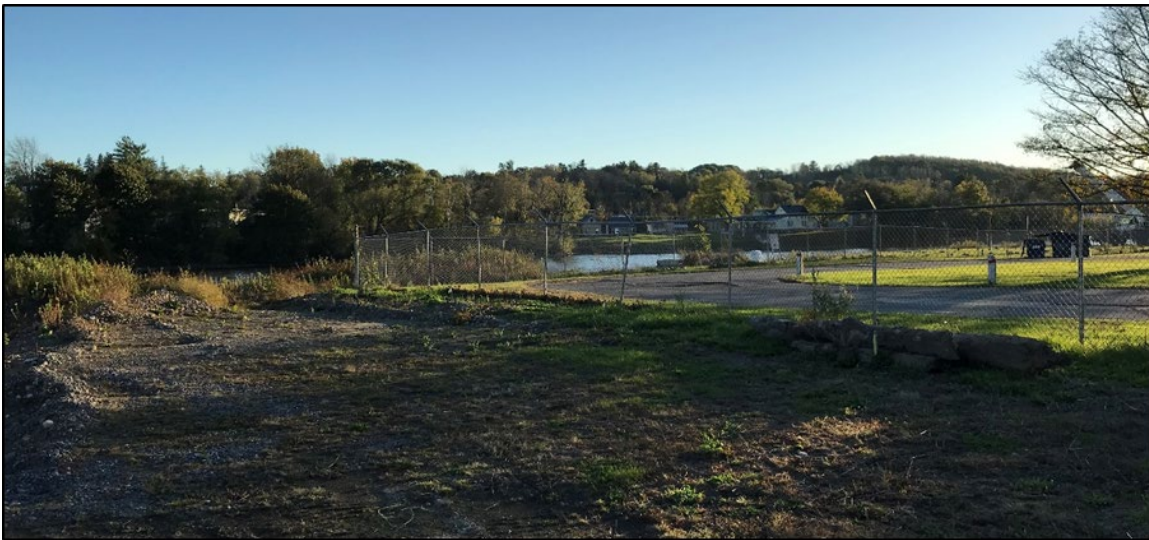
View from Fonda Terminal and Canal Shops, looking south toward the Project area.

View from Fonda Shops looking southwest toward the Project area.

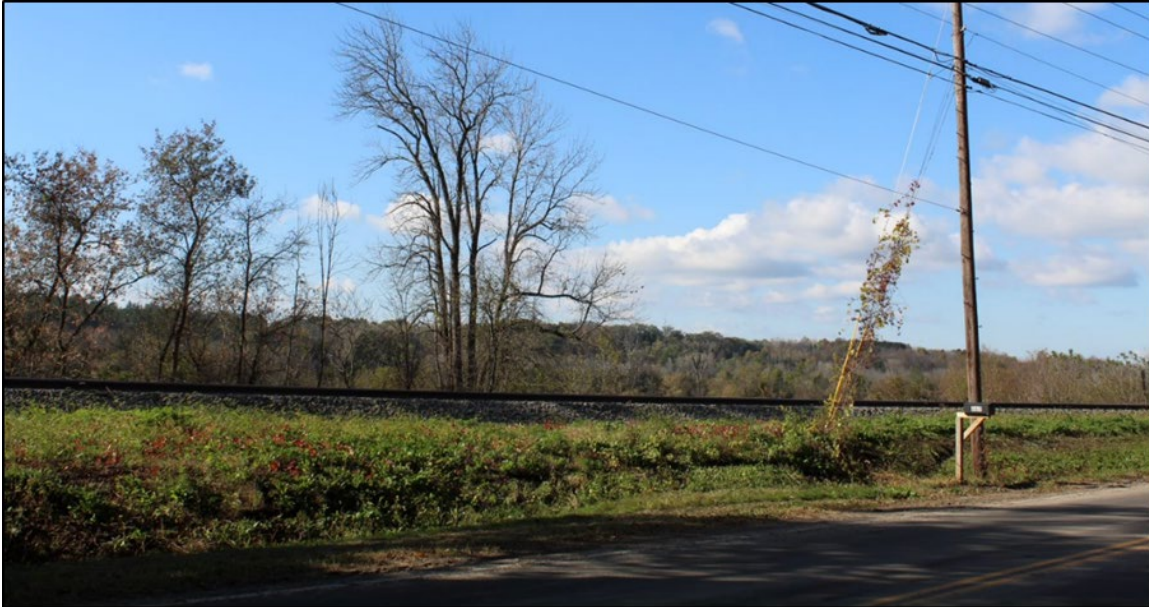
View from Danascara Place south southwest toward Project area blocked by vegetation.

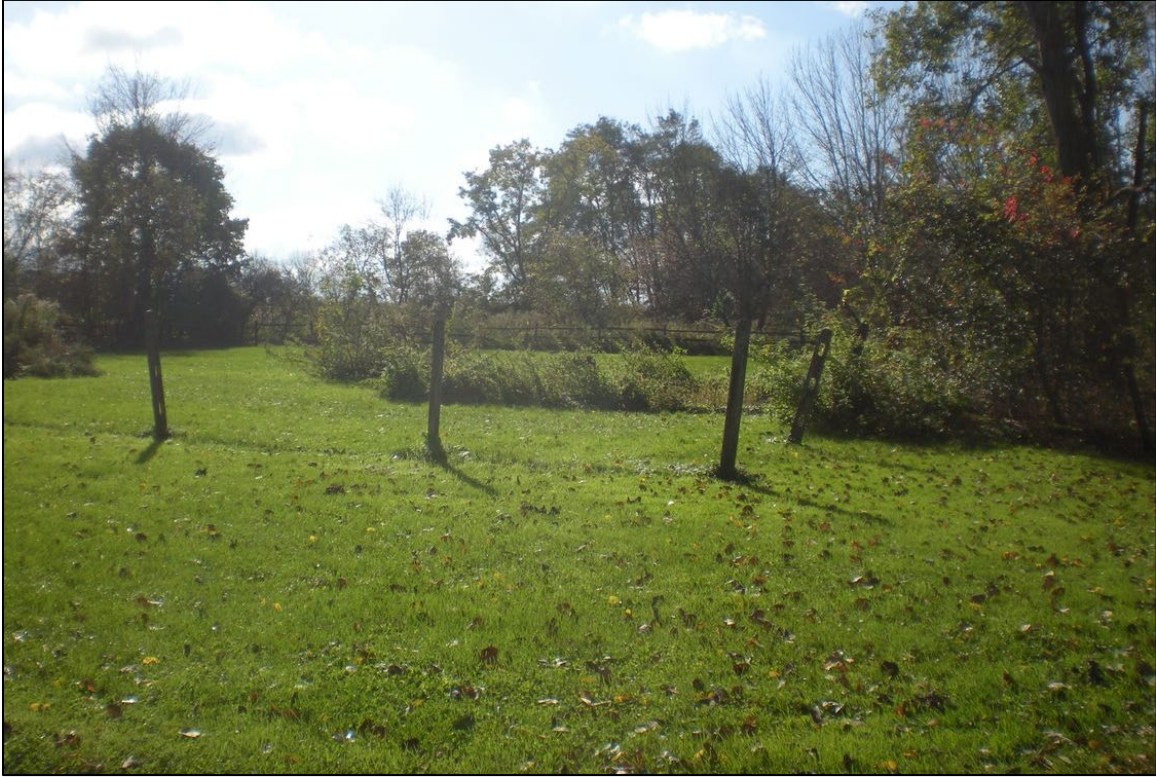
View from Walter Butler Homestead south toward Project area, vegetation and intervening topography block views.

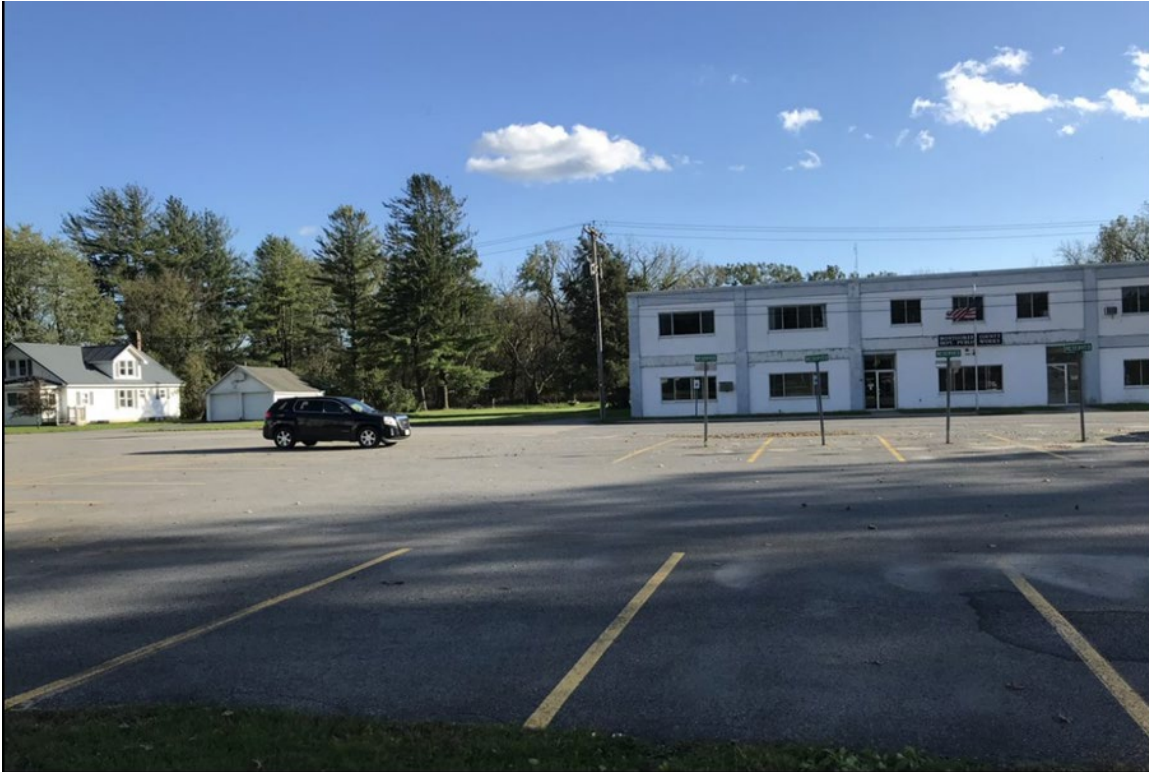
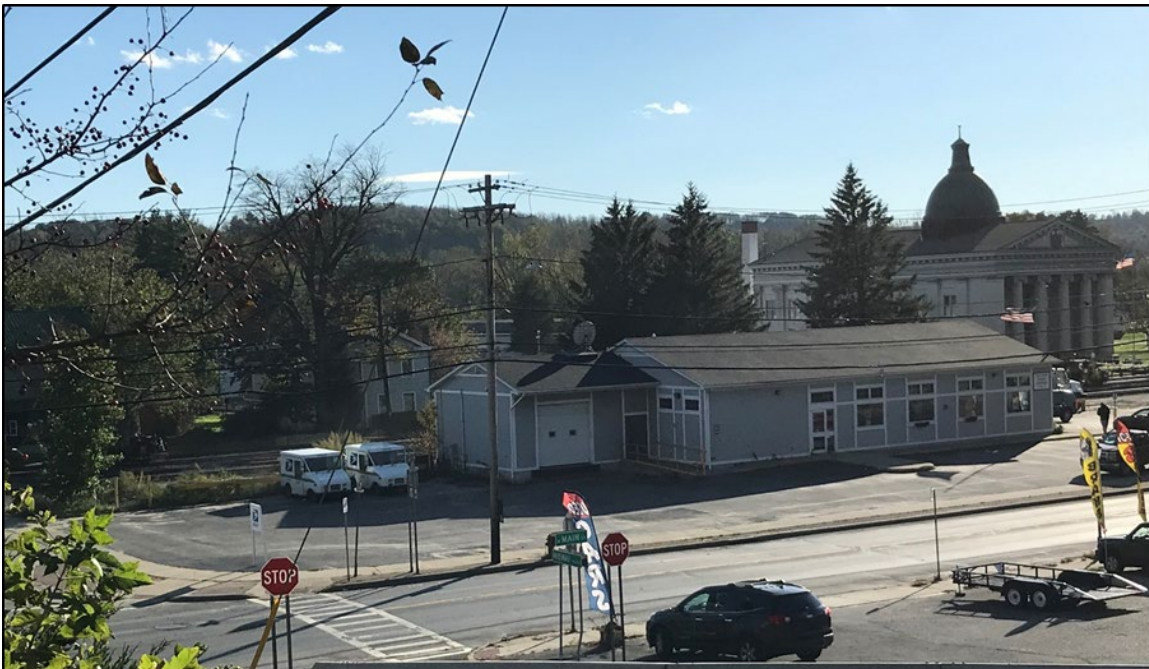
View from the Old Montgomery Courthouse looking south. Other structures and vegetation block views of the Project area.

View from Center Street at Main Street of the Old Montgomery Courthouse facing southwest, toward the Project area.

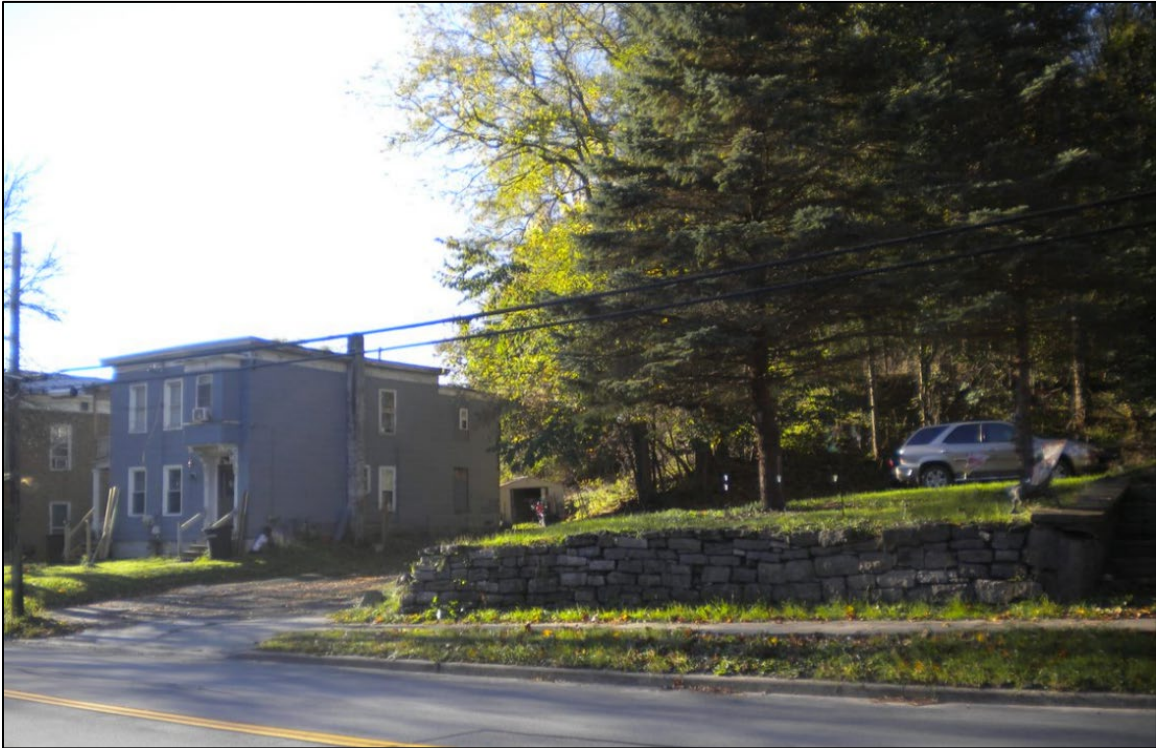
View from New Montgomery Courthouse looking south across the street, vegetation and other structures block views of Project area.

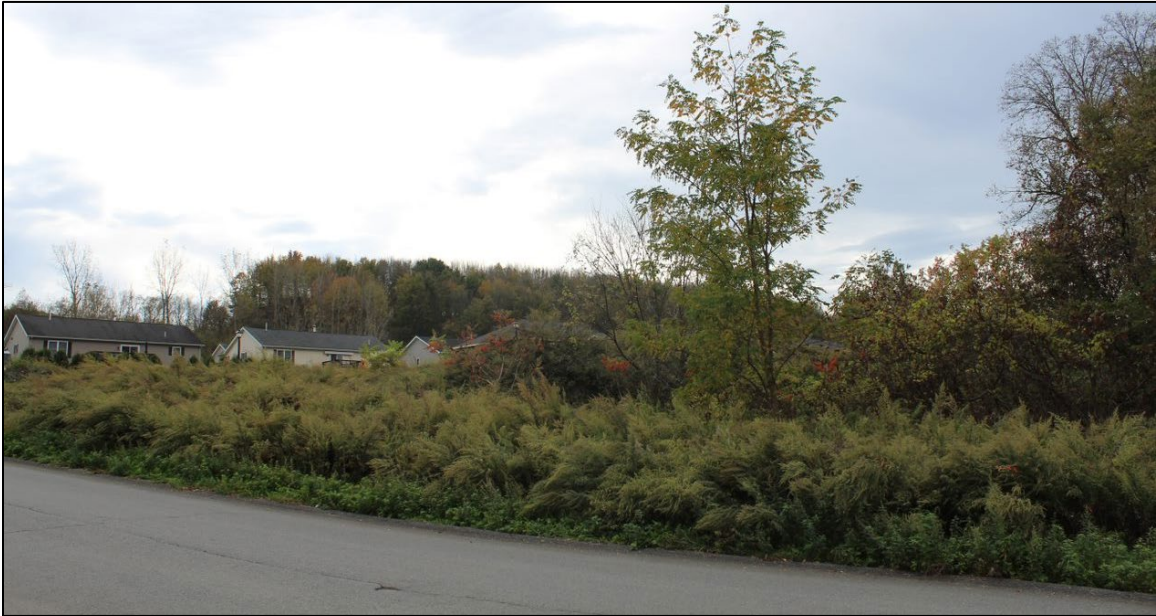
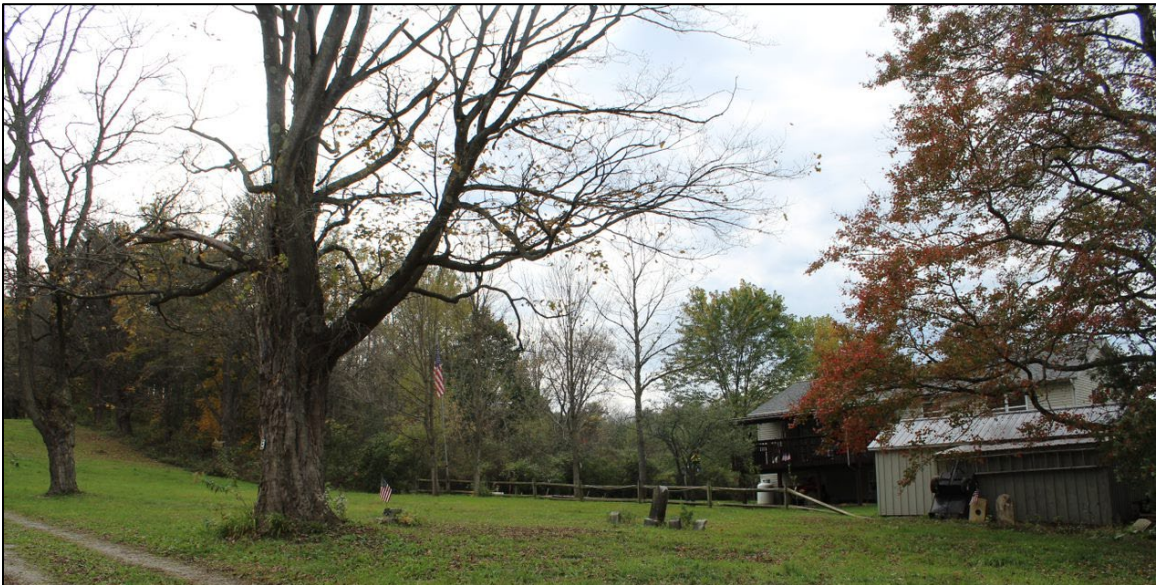
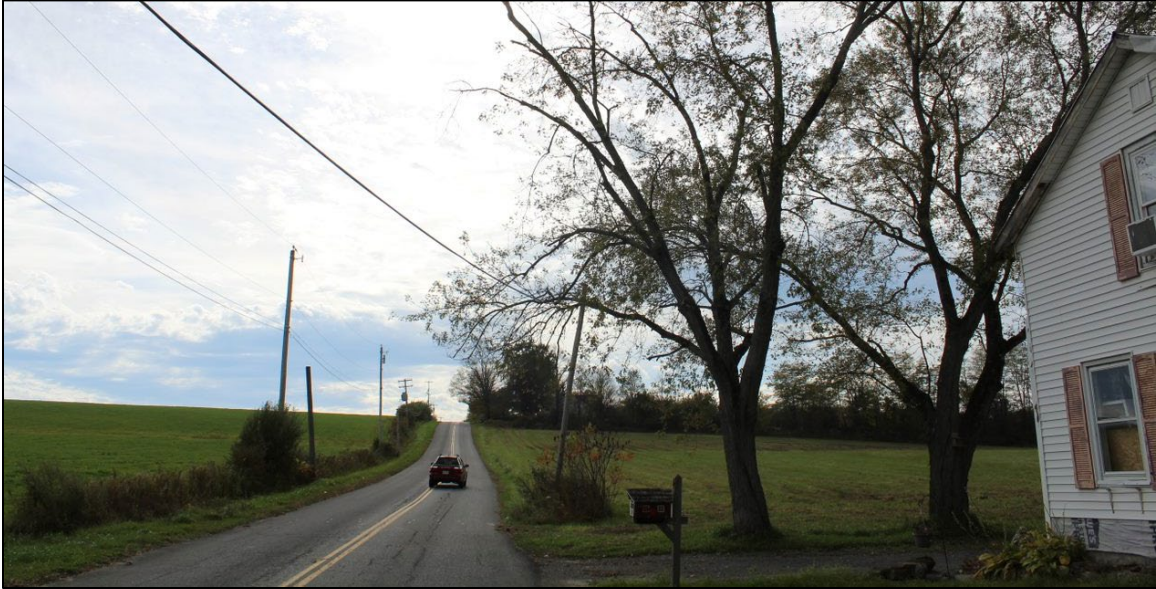
View from southwest corner of Fultonville Historic District at Conable Drive looking west toward Project area.

View from Old Fultonville Cemetery in Fultonville Historic District, facing southwest, toward Project area.

View from Van Epps Road at southern point of Fultonville Historic District, looking southwest toward the Project area.

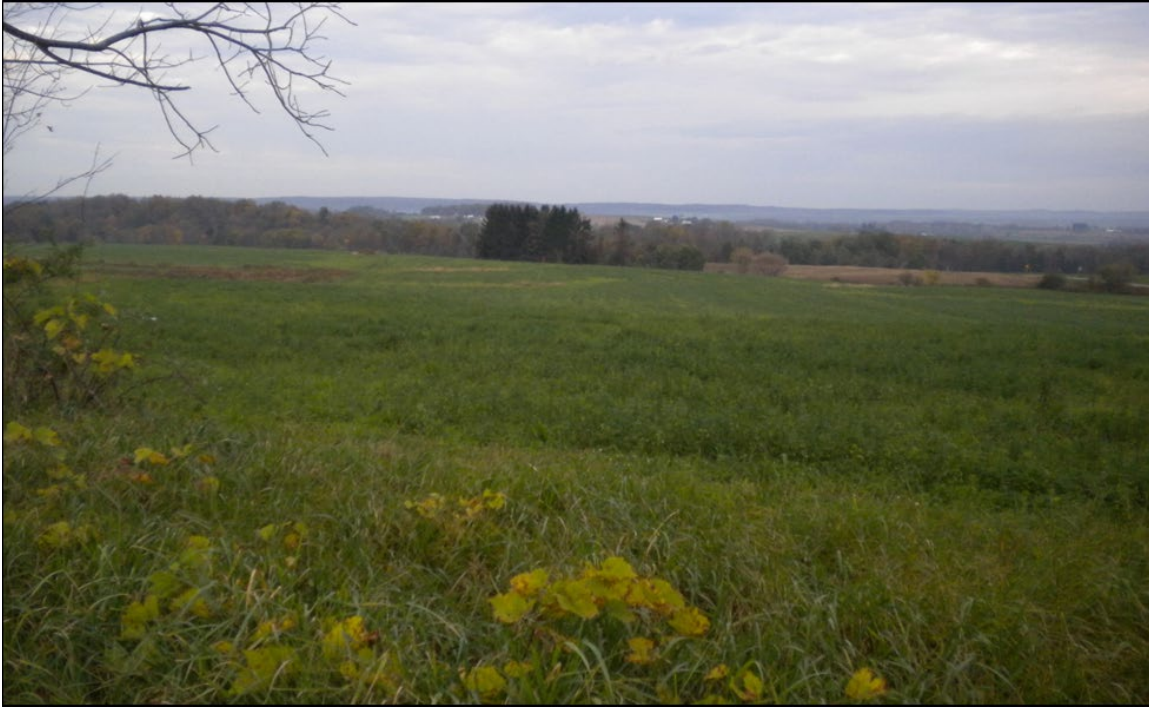
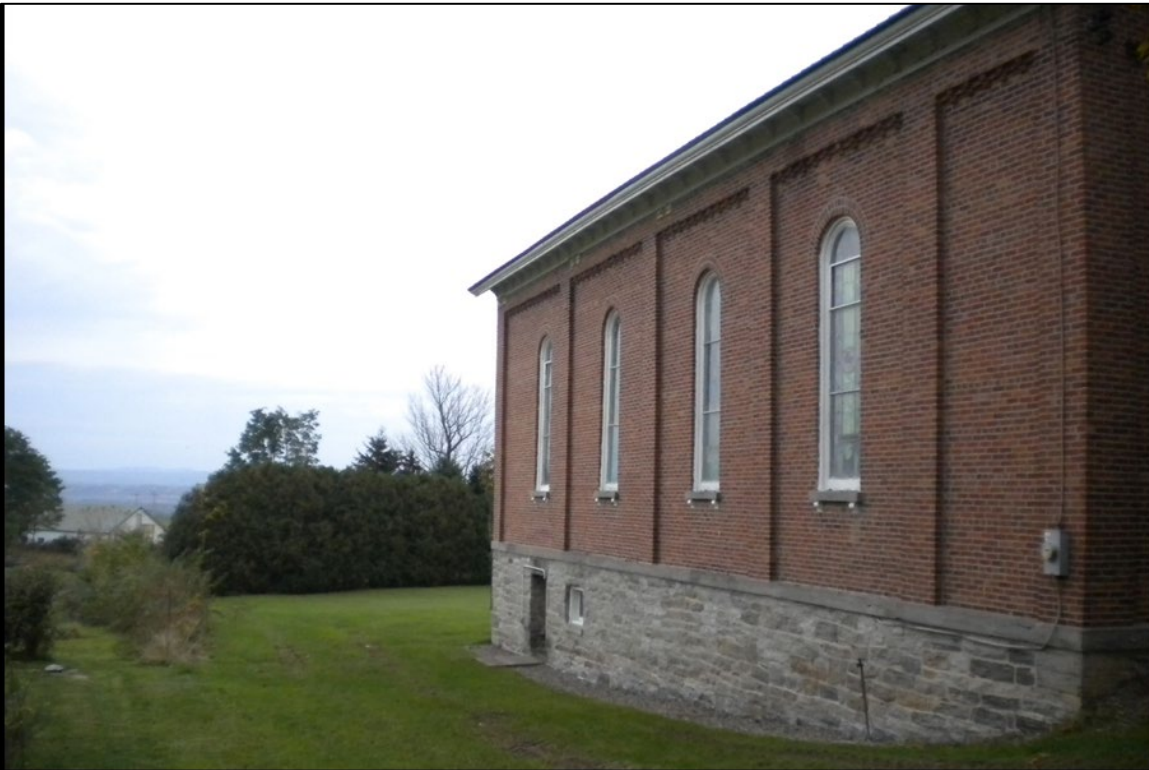
View from 110 Logtown Road, facing northwest into Project area parcels.

View from Glen Reformed Church, north, toward proposed Project parcels.

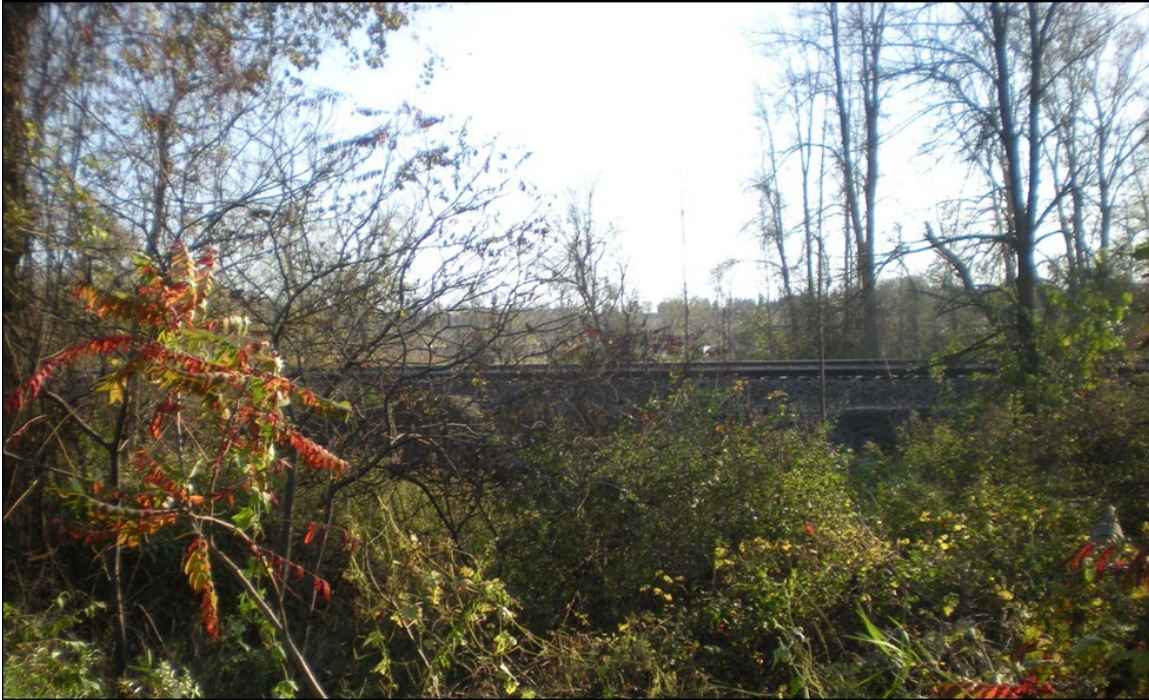
View is south from Klock House looking toward the Project area showing railroad and vegetation.
